### HB Regional Hospital, Hastings

### HBDHB DESCRIPTION – Emergency Department HA25

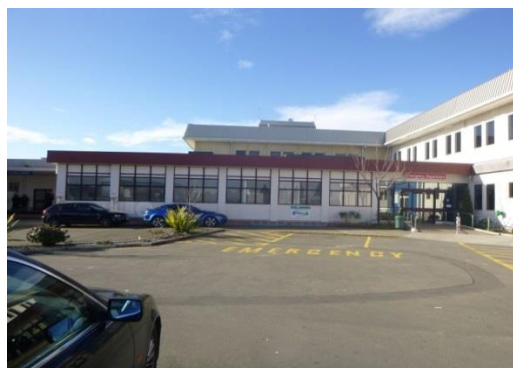
The Emergency Department is assessed as **88% NBS** when considered as an IL4 building.
