HB Regional Hospital, Hastings

HBDHB DESCRIPTION – Orthotics (Villa 8) HA47

2-S5000.00

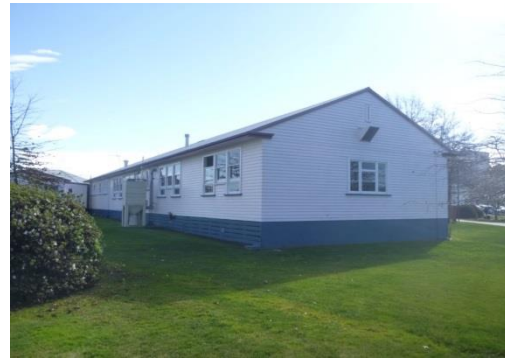
Building Name:	Orthotics (Villa 8)	Building Use:	Medical Services
Design/Constructed/Upgraded:	1940's	Importance Level	2
General Shape:	Rectangular	No. of Storeys:	1
Longitudinal Lateral Load Resisting System:	Light timber framing	Transverse Lateral Load Resisting System:	Light timber framing
Foundation System:	Concrete piles	Other Level Floor Systems:	Flexible timber floor
Roof System:	Light timber and steel clad roof	Primary Cladding Type:	Timber weatherboards
Most Recent Previous Assessment:	Year: 2005 2013	By: Holmes Consulting Group Opus	Assessment: Informal SPS 80% IEP 20% NBS
Other Comments:	2014: DSA by Opus 54% NBS (IL2)
