HB Regional Hospital, Hastings

HBDHB DESCRIPTION – Community Health HA48

2-S5000.00

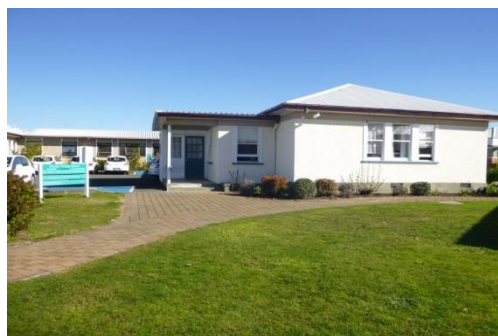
Building Name:	Community Health	Building Use:	Medical Services
Design/Constructed/Upgraded:	1940's	Importance Level	3
General Shape:	Irregular	No. of Storeys:	1
Longitudinal Lateral Load Resisting System:	Light Timber Framed Structure	Transverse Lateral Load Resisting System:	Light Timber Framed Structure
Foundation System:	Concrete ring beam & piles	Other Level Floor Systems:	N/A
Roof System:	Light timber truss , steel clad	Primary Cladding Type:	Stucco cladding
Most Recent Previous Assessment:	Year: 2005 By: Holmes Consulting Group Assessment: Informal SPS 80%		
Other Comments:	IEP constrained by date of construction, Candidate for comprehensive ISA

Community Health is assessed as **37% NBS** when considered as an IL3 building.

Longitudinal	Transverse
Baseline %NBS	16	16
Factors Influencing Baseline	-	-
Critical Structural Weaknesses	-	-
Modification Factors	2.25	2.25
Influence on Modification Factor	MOE Guidelines, multiple internal walls, reduction for heavy stucco cladding.	
%NBS	37% NBS	37% NBS
