HB Regional Hospital, Hastings

HBDHB DESCRIPTION – Addiction Services HA52

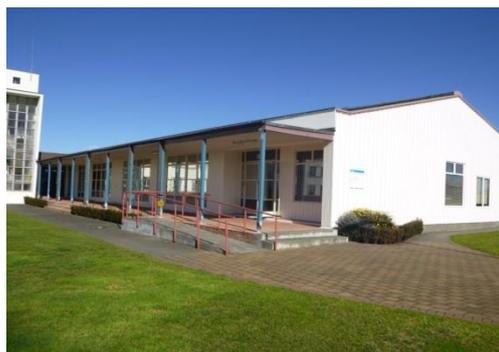
Longitudinal	Transverse
Baseline %NBS	-	-
Factors Influencing Baseline	-	-
Critical Structural Weaknesses	Exterior wall brickwork is a potential CSW-	Exterior wall brickwork is a potential CSW -
Modification Factors	-	-
Influence on Modification Factor	-	-
%NBS	50% NBS	100% NBS
