**HB Regional Hospital,  
Hastings****HBDHB DESCRIPTION – Cashmore  
HA53**

2-S5000.00

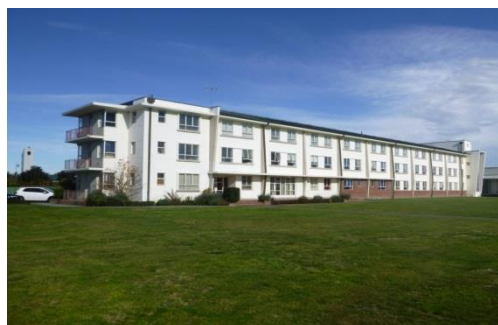
<b>Building Name:</b>	Cashmore	<b>Building Use:</b>	Administration
<b>Design/Constructed/Upgraded:</b>	1959	<b>Importance Level</b>	2
<b>General Shape:</b>	Rectangle	<b>No. of Storeys:</b>	3 + Basement
<b>Longitudinal Lateral Load Resisting System:</b>	R C Walls	<b>Transverse Lateral Load Resisting System:</b>	R C Walls and Frames
<b>Foundation System:</b>	Unknown	<b>Other Level Floor Systems:</b>	Ground Floor – Timber Floor
<b>Roof System:</b>	Concrete Slabs	<b>Primary Cladding Type:</b>	Plastered
<b>Most Recent Previous Assessment:</b>	<b>Year: 2007 By: Holmes Consulting Group Assessment: DSA 60%</b> <b>Year: 2013 By: Opus Assessment: IEP 38%NBS (IL2)</b>		
<b>Other Comments:</b>	2017: DSA by Opus 58% NBS (IL2)

Cashmore is assessed as **58% NBS** when considered as an IL2 building.
