HB Regional Hospital, Hastings

HBDHB DESCRIPTION – Maori Health HA54

2-S5000.00

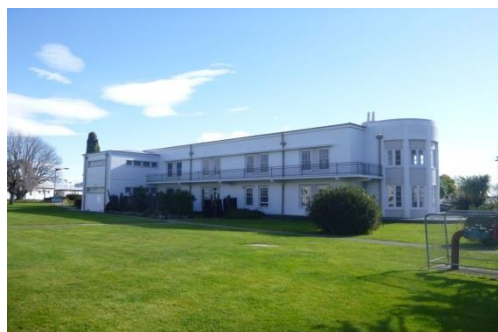
Building Name:	Maori Health	Building Use:	Medical Services
Design/Constructed/Upgraded:	1941	Importance Level	2
General Shape:	Square + Rectangle	No. of Storeys:	2
Longitudinal Lateral Load Resisting System:	Concrete Walled	Transverse Lateral Load Resisting System:	Concrete Walled
Foundation System:	Strip Footing	Other Level Floor Systems:	First floor-Concrete Slab
Roof System:	Unknown	Primary Cladding Type:	Unknow
Most Recent Previous Assessment:	Year: 2007 By: Holmes Consulting Group Assessment: DSA 35%		
Other Comments:	2017: A DSA is currently being undertaken

Maori Health is assessed as **35% NBS** when considered as an IL2 building.
