### HB Regional Hospital, Hastings

### HBDHB DESCRIPTION – Shed HA65

2-S5000.00

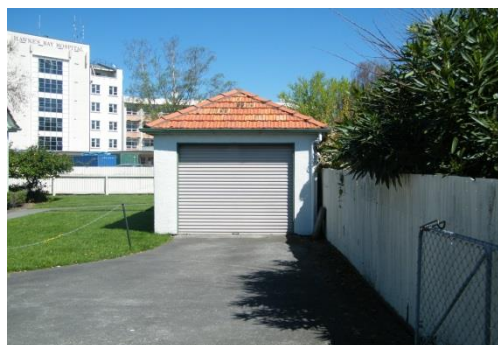
<b>Building Name:</b>	Shed	<b>Building Use:</b>	Storage
<b>Design/Constructed/Upgraded:</b>	Unknown (Possible 1940's as per House)	<b>Importance Level</b>	1
<b>General Shape:</b>	Rectangle	<b>No. of Storeys:</b>	1
<b>Longitudinal Lateral Load Resisting System:</b>	Light timber framing	<b>Transverse Lateral Load Resisting System:</b>	Light timber framing
<b>Foundation System:</b>	Concrete pad	<b>Other Level Floor Systems:</b>	N/A
<b>Roof System:</b>	Tiled roof	<b>Primary Cladding Type:</b>	Stucco
<b>Most Recent Previous Assessment:</b>	<b>Year:</b> None <b>By:</b> None <b>Assessment:</b> None		
<b>Other Comments:</b>	Roof tile fixing may need attention

Shed is assessed as **71% NBS** when considered as an IL1 building.
