# **AAU Histology Block Hawke's Bay Hospital**

**Detailed Seismic Assessment**

# **AAU, Pharmacy, Dialysis Block HA34**

### **Detailed Seismic Assessment**

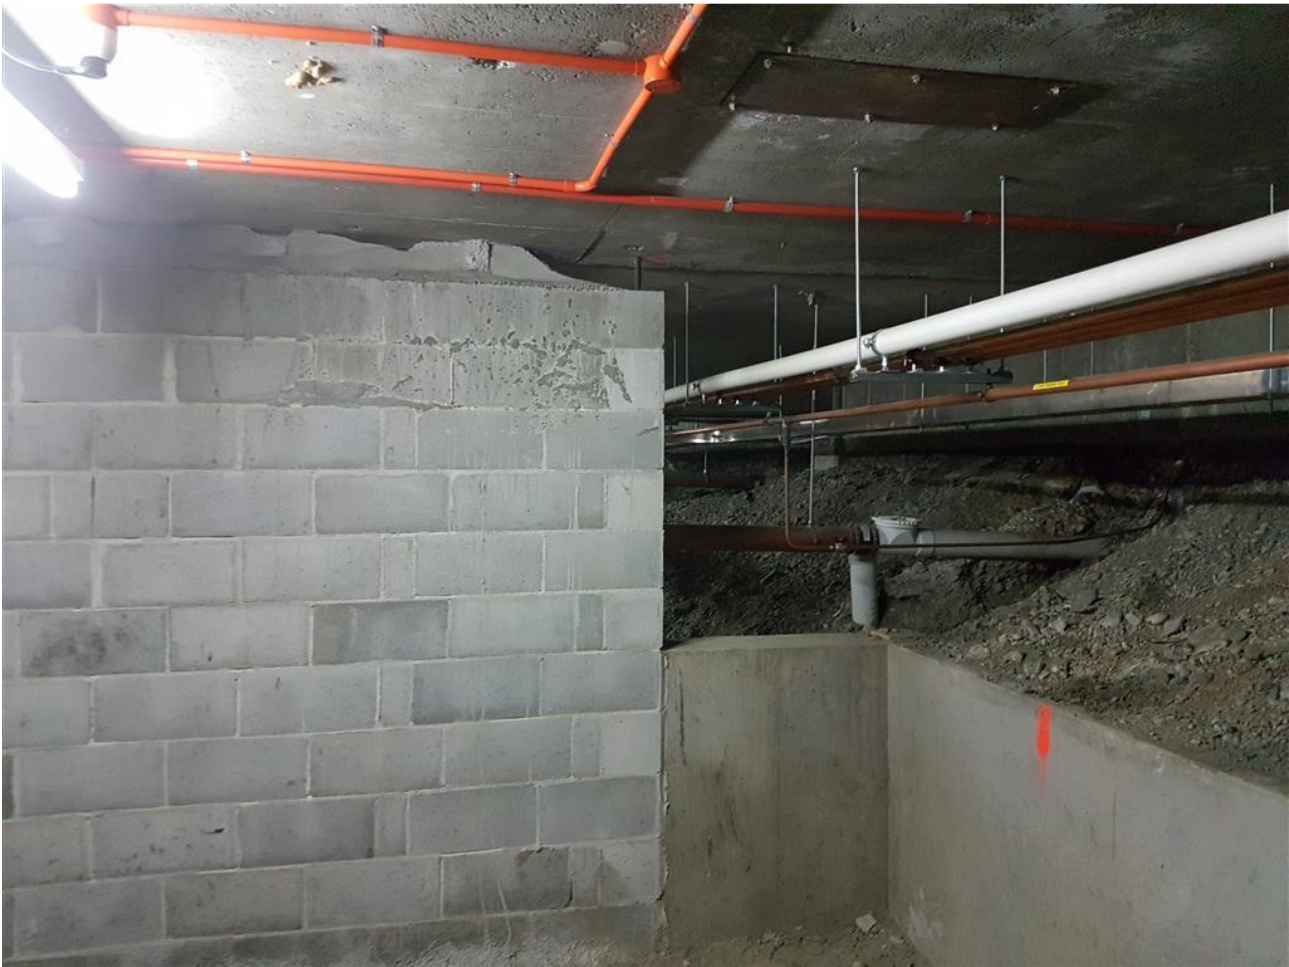
**Figure 20: Example of RCM wall with incomplete infill and lack of dowel action at top.**

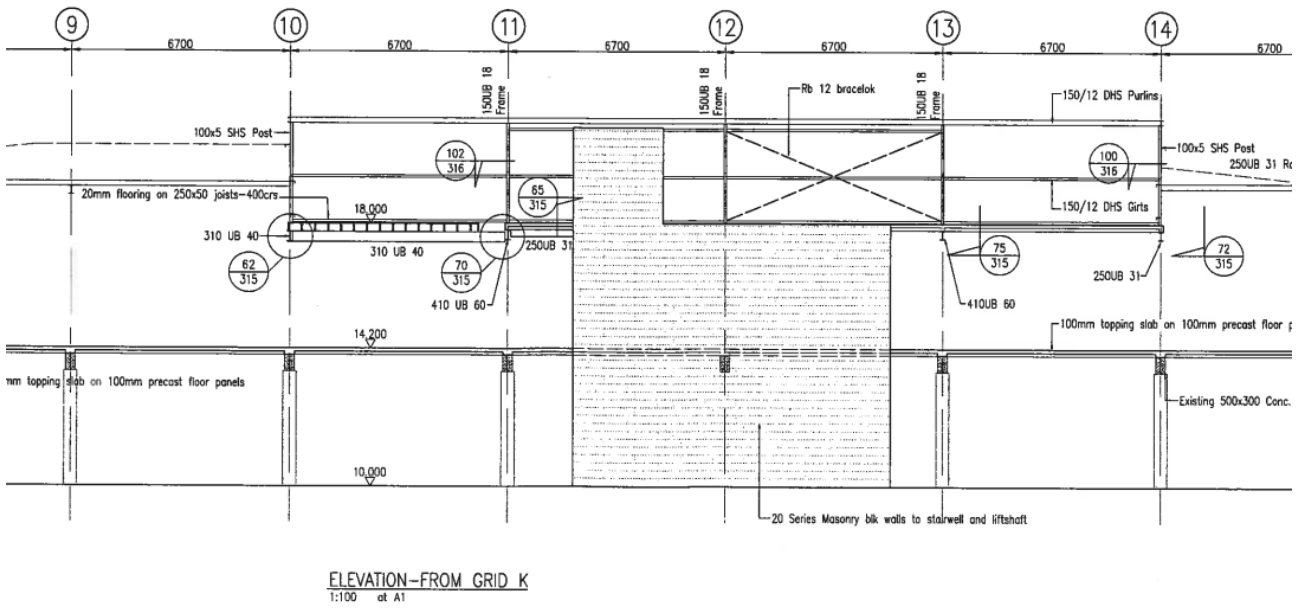
Figure 25: Elevation from Grid K – Connection of wall to structure not confirmed.

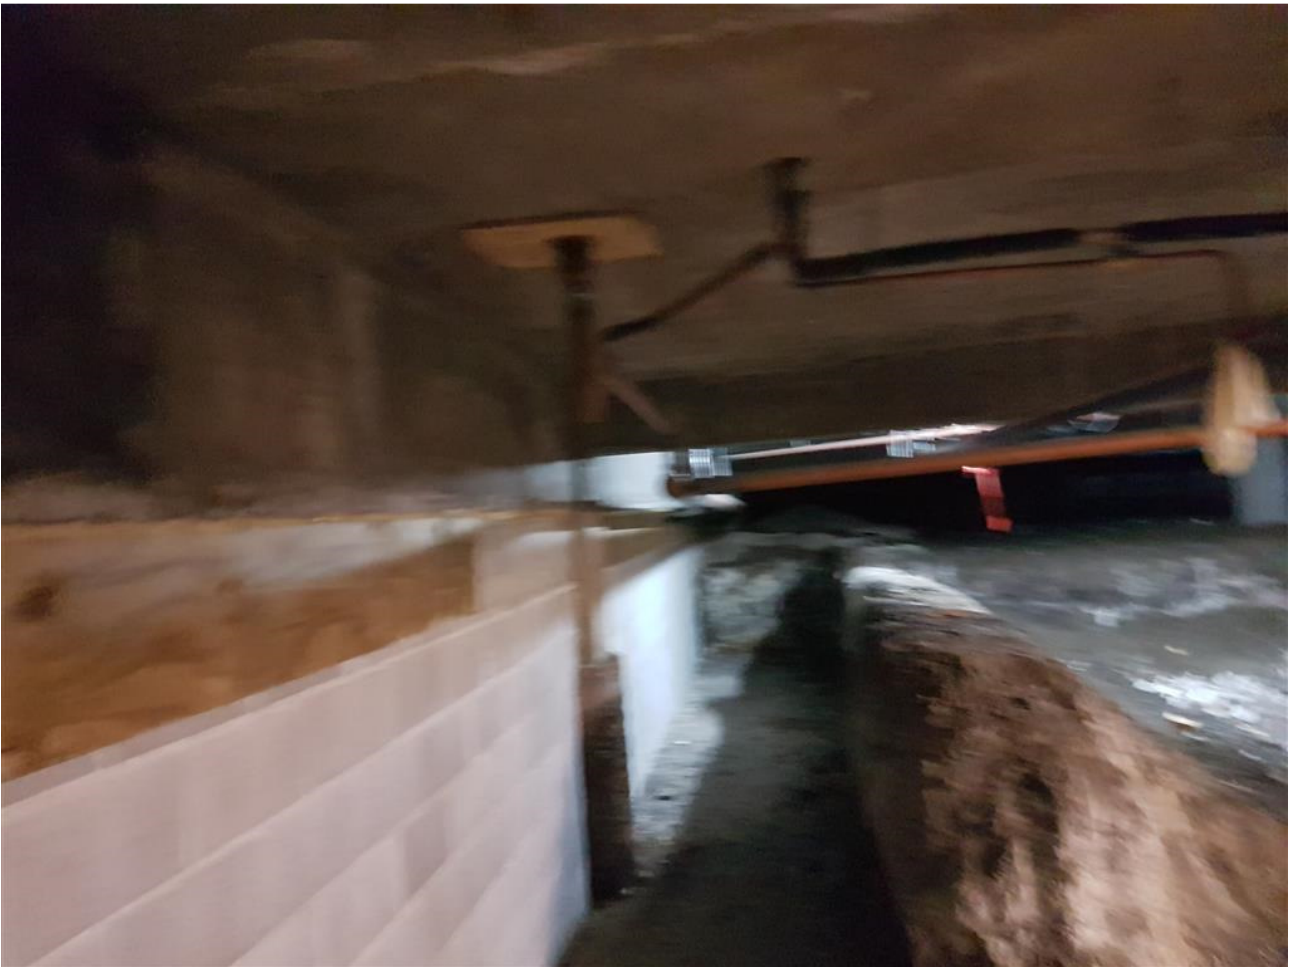
**Figure 39: Walls 3 and 4**

- Length= 6100mm
- Height=2000mm (2200 mm from as-built drawings)
- No Openings
- Assumptions: none.
- Structural Weaknesses: not properly doweled to beams. No dowel action, no strut action. Ineffective wall?

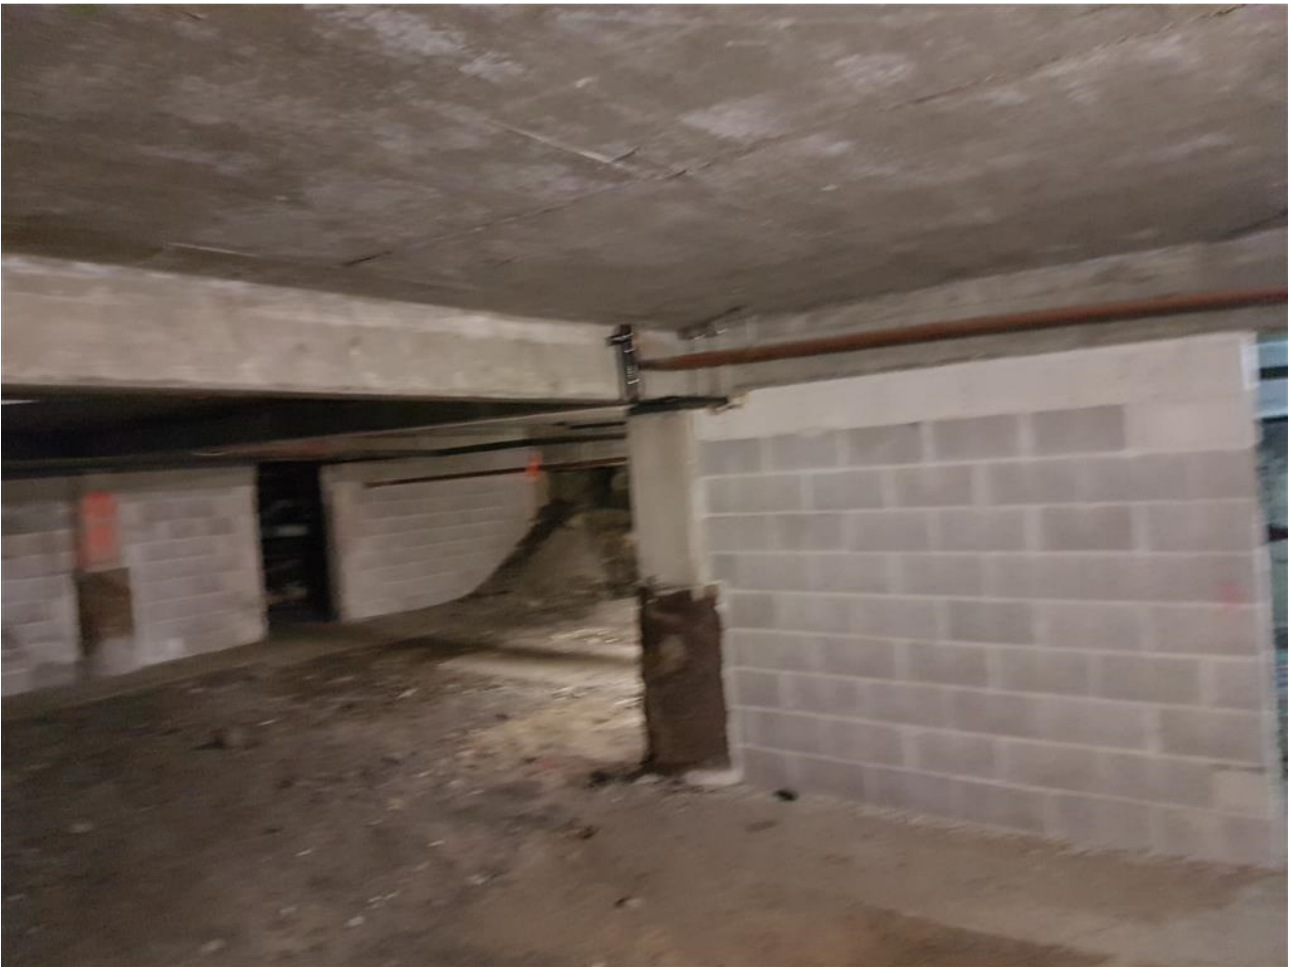
**Figure 41: Wall No. 7, Right, with opening.**

- Length= 2400mm+Doorway+2900mm
- Height=2000mm (1800 mm from as-built drawings)
- Opening: door through middle
- Assumptions: Strut can be formed.
- Structural Weaknesses: Opening, diminishing shear strength of wall. Failure mechanism by dowel failure in non-ductile mode. Probable shear failure of columns if strut action takes place.

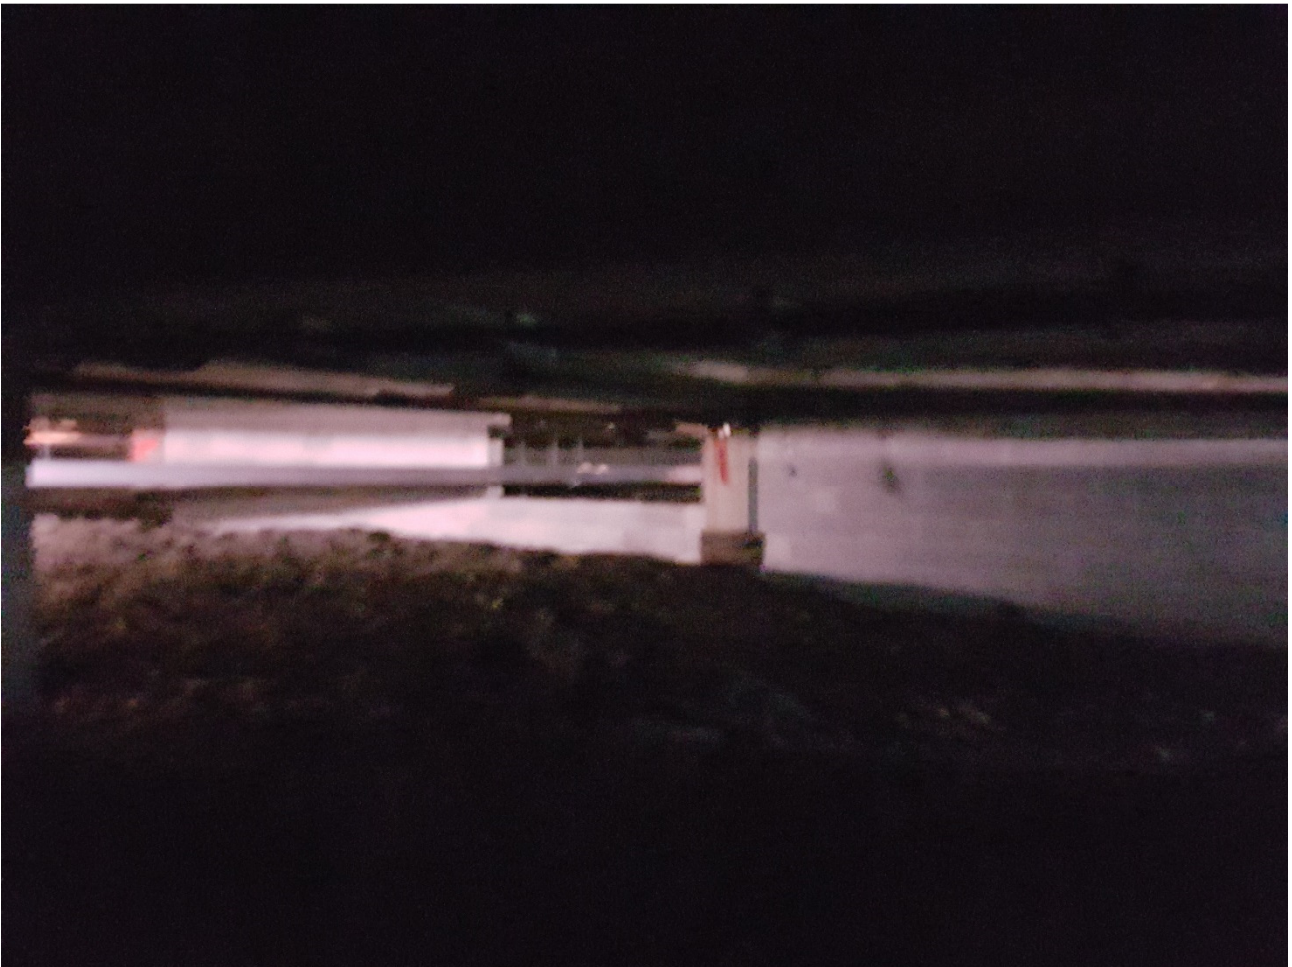
**Figure 43: Wall 9 (left) and 10 (right)**

- Length= 6100
- Height=2000mm (2000 mm from as-built drawings)
- Opening: Opening 800x2400
- Assumptions: Strut can be formed at lower part of wall.
- Structural Weaknesses: Opening.

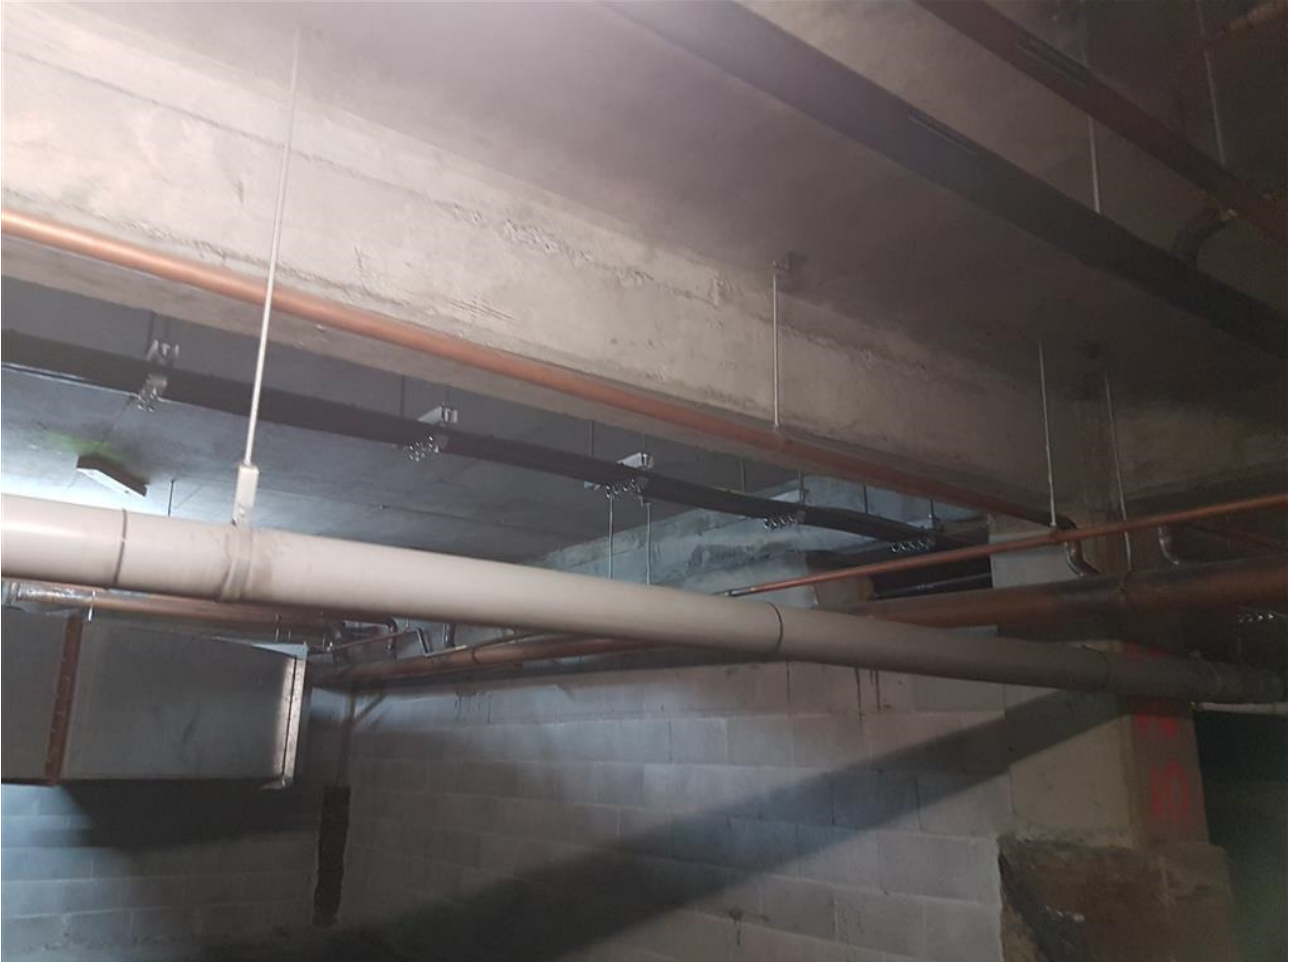
**Figure 44: Wall 11 and 28 (right)**

- Structural Weaknesses: Strut cannot be formed except at lower part of column. Reduced shear capacity.

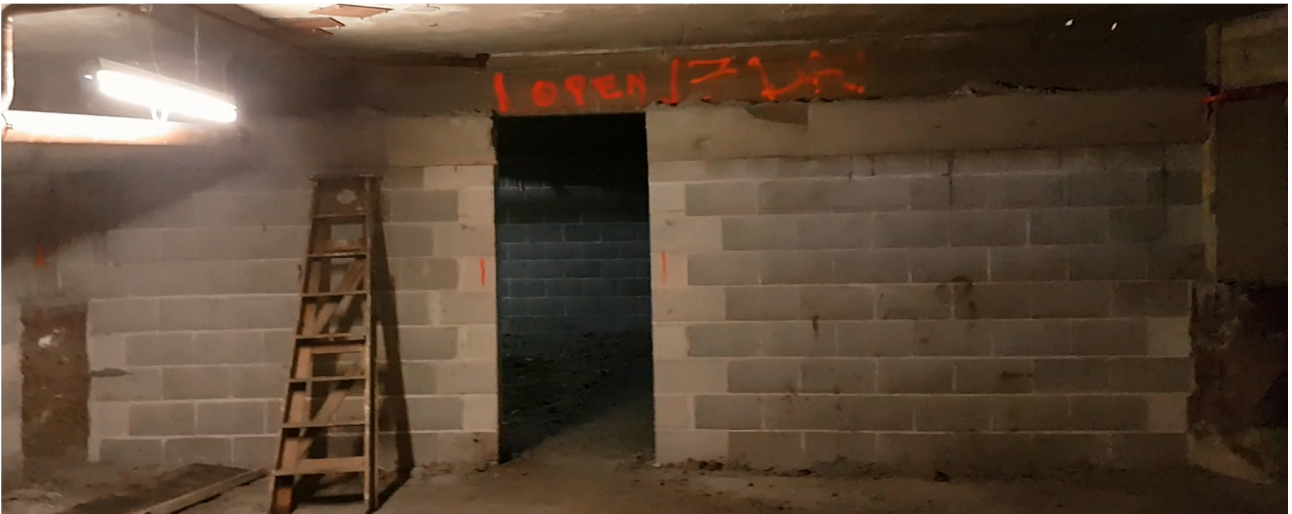
Figure 46: Wall 13

- Length= 2600mm+opening 800mm+2900mm
- Height=2000mm (1900 mm from as-built drawings)
- Opening: Door
- Assumptions: None.
- Structural Weaknesses: Door, dowels 70%grouted. Probable shear failure of column.

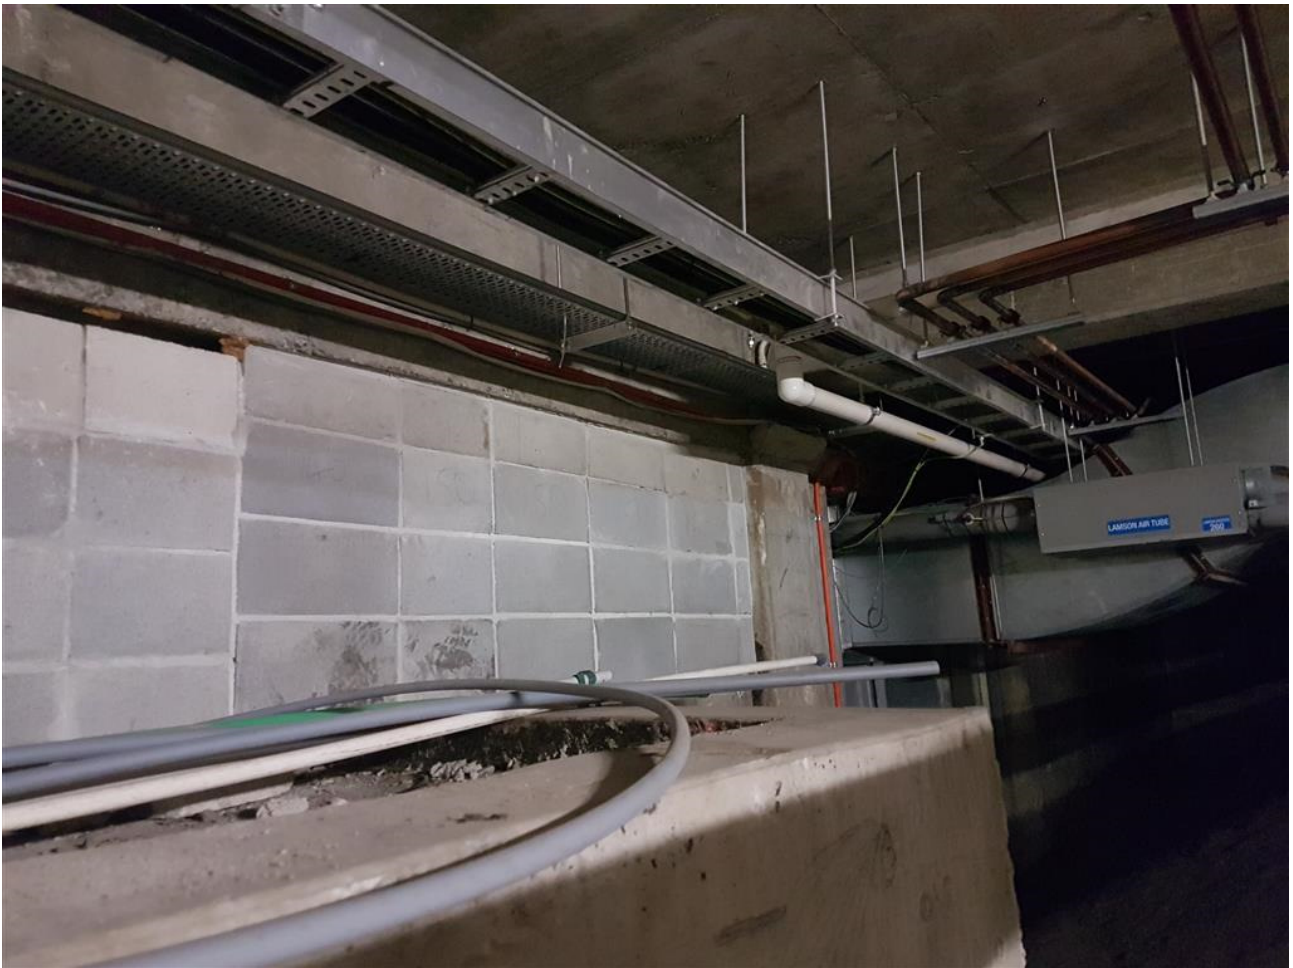
**Figure 50: Walls 18**

- Assumptions: none
- Structural Weaknesses: Not properly dowelled, bond not continuous.

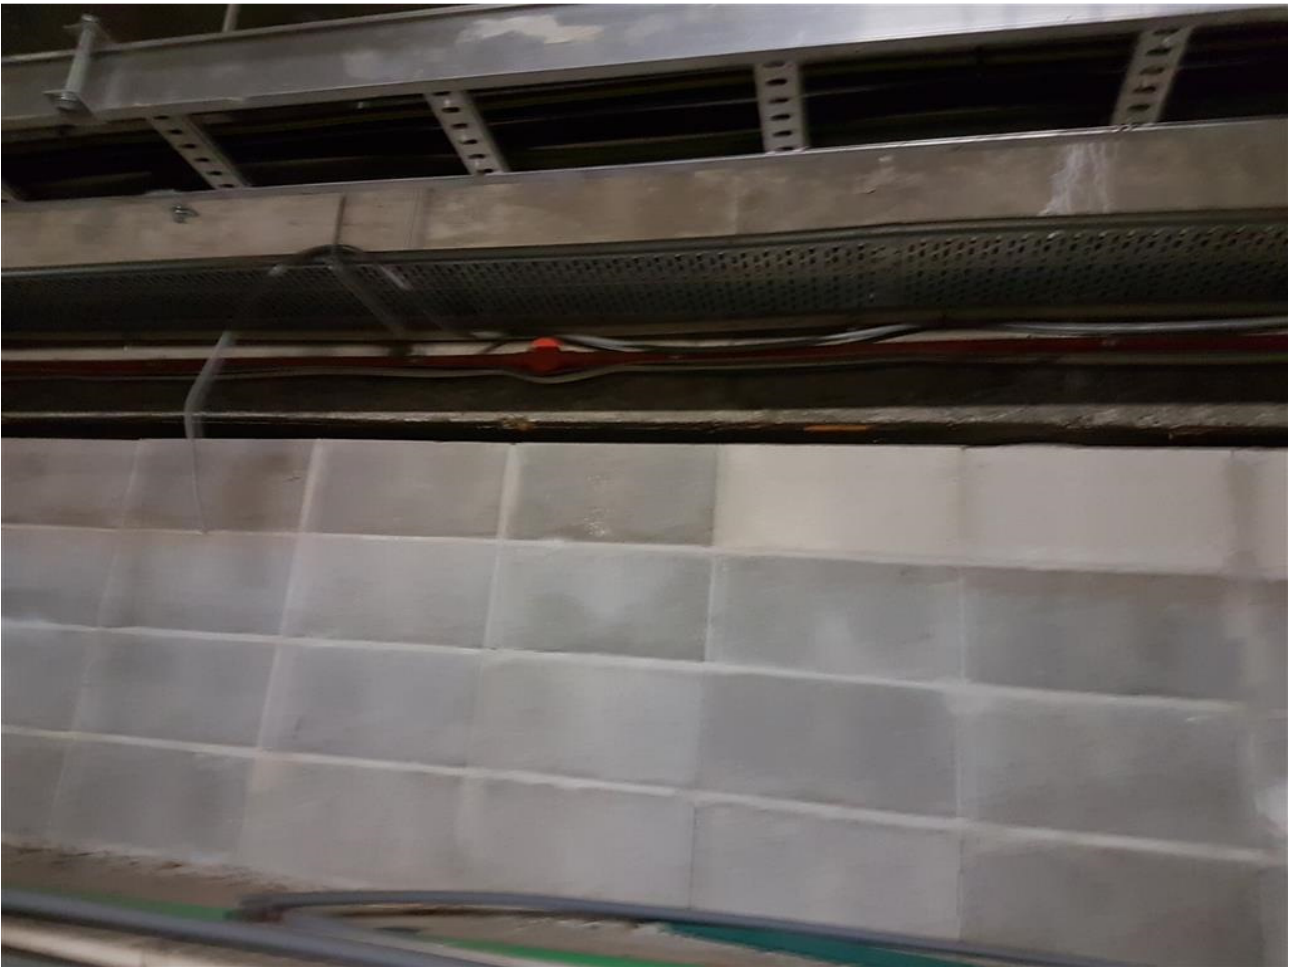
**Figure 51: Wall #19**

- Length= 6100mm
- Height=800mm
- Opening: No Openings.
- Assumptions: none
- Structural Weaknesses: Not properly dowelled, stack bond not continuous.

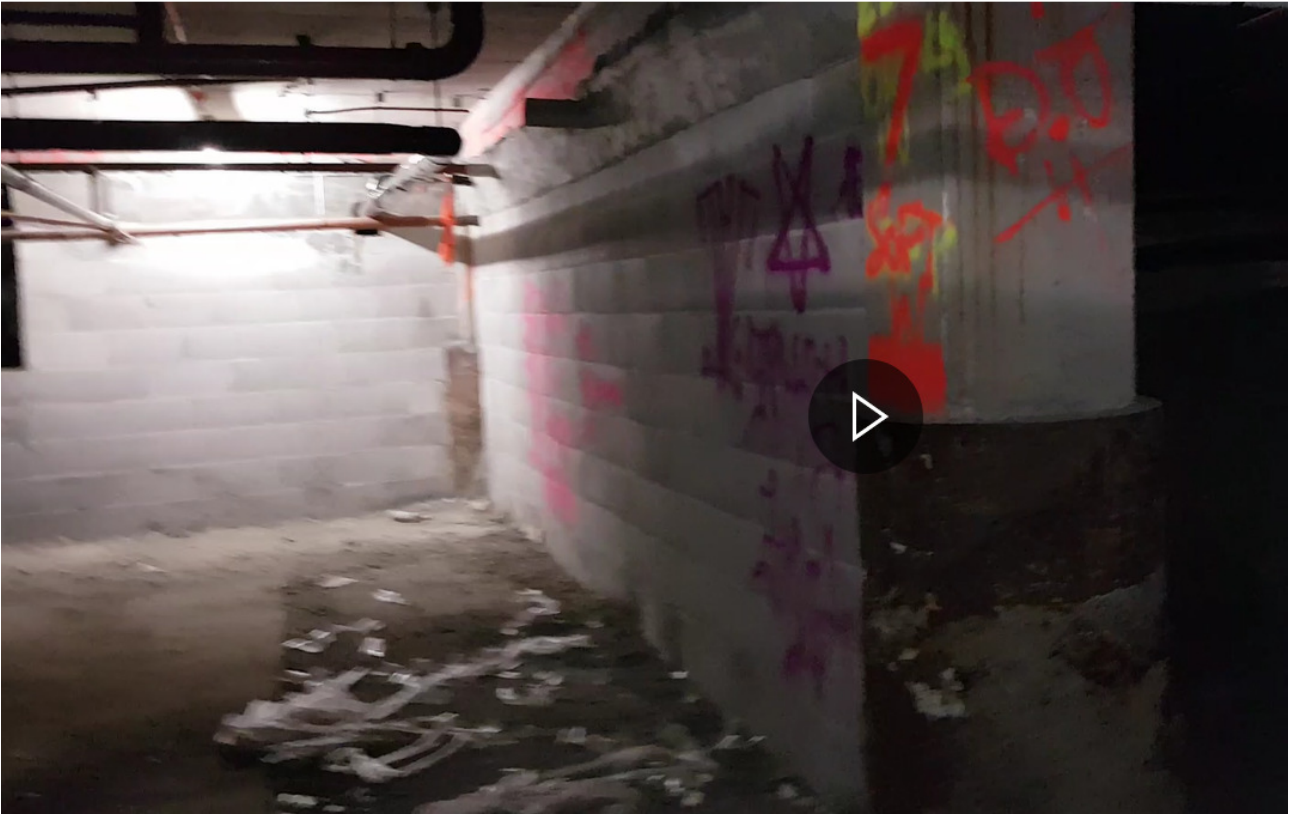
**Figure 52: Wall #20 (left) and #5 (right)**

- Length= 2000 mm
- Height=1400 mm
- Opening: No Openings.
- Assumptions: Height.
- Structural Weaknesses: Not properly dowelled, Only small portion of wall, no framing action, limited shear action.

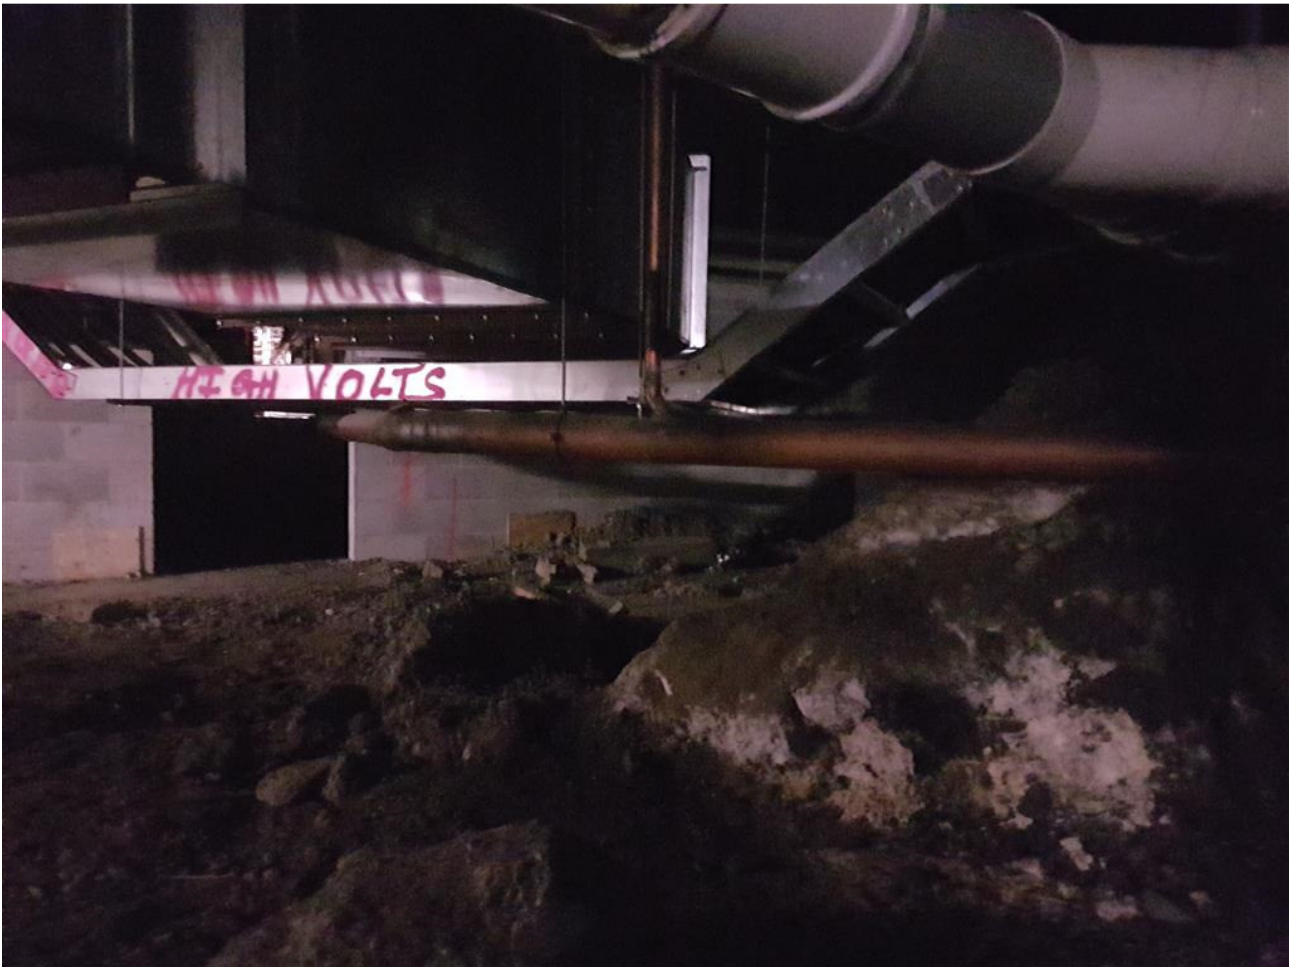
- Length= 3200 mm+Opening+1900mm
- Height=2000 mm (1400 from drawings)
- Opening: Doorway.
- Assumptions: None.
- Structural Weaknesses: 1900mm length portion not to full height. Not taken into account.

**Figure 53: Wall #21 – Uncomplete height on left, lack of dowels on right**

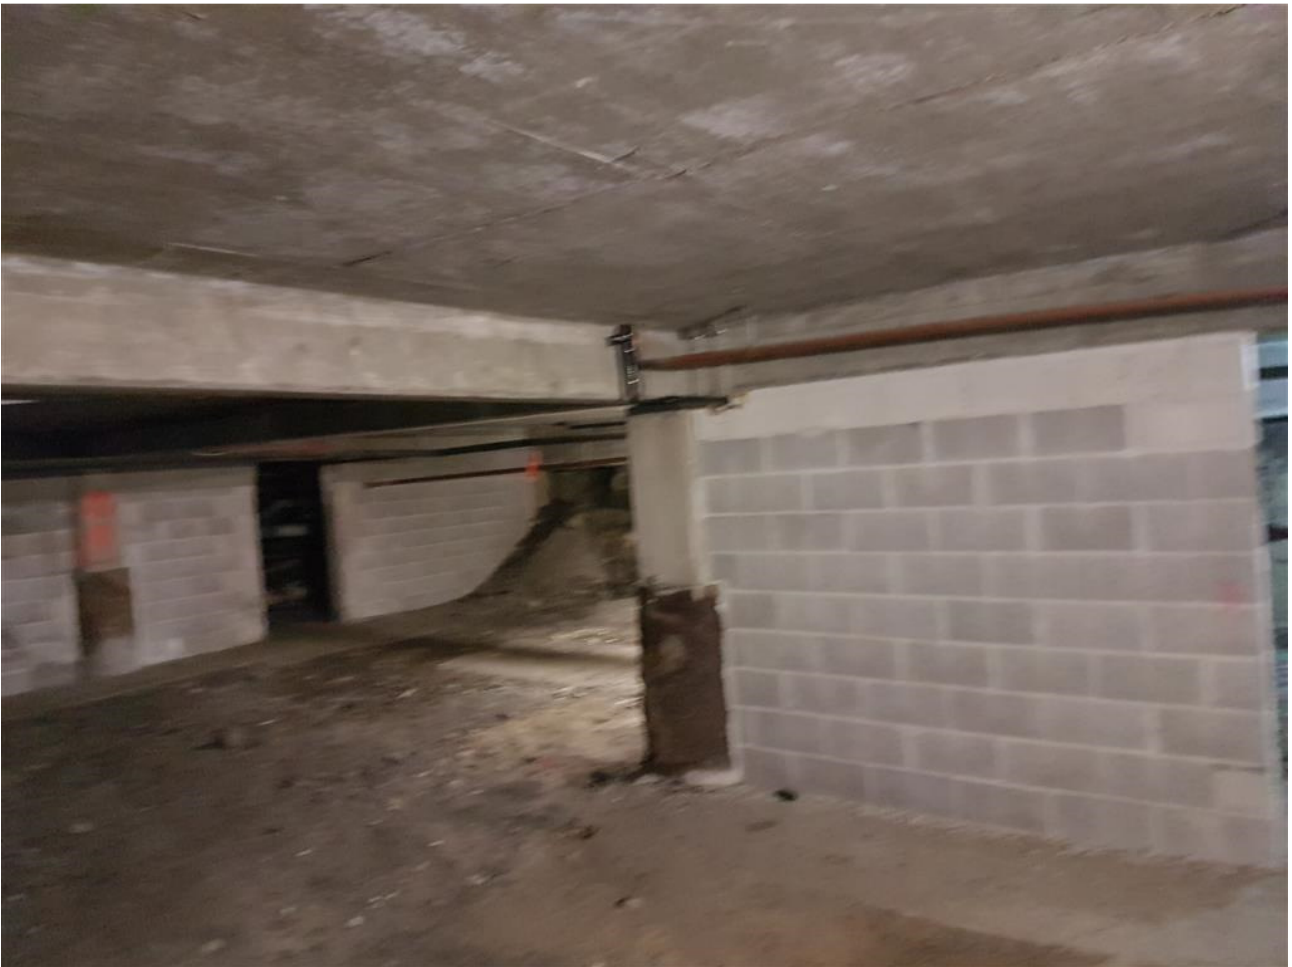
**Figure 54: Wall #22 – Rear**

- Length= 1400mm+Opening+3000mm
- Height=2000 mm (1400 from drawings)
- Opening: Doorway
- Assumptions: Well dowelled.
- Structural Weaknesses: No strut action.

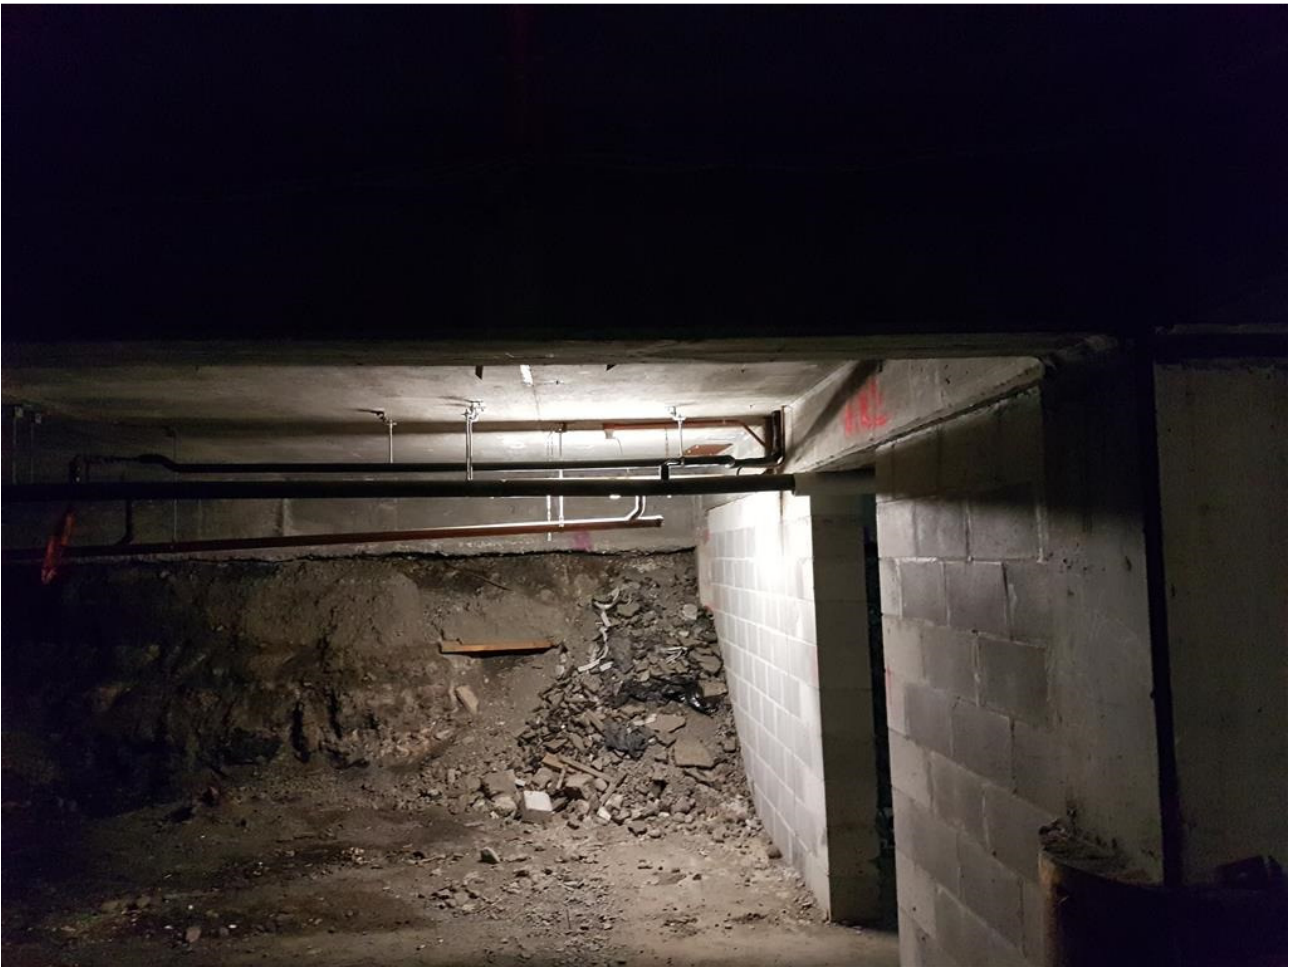
**Figure 55: Wall #23 – Rear**

- Length= 1300mm+Opening+3200mm
- Height=2000 mm (1800 from drawings)
- Opening: Doorway
- Assumptions: Well dowelled.
- Structural Weaknesses: No strut action.

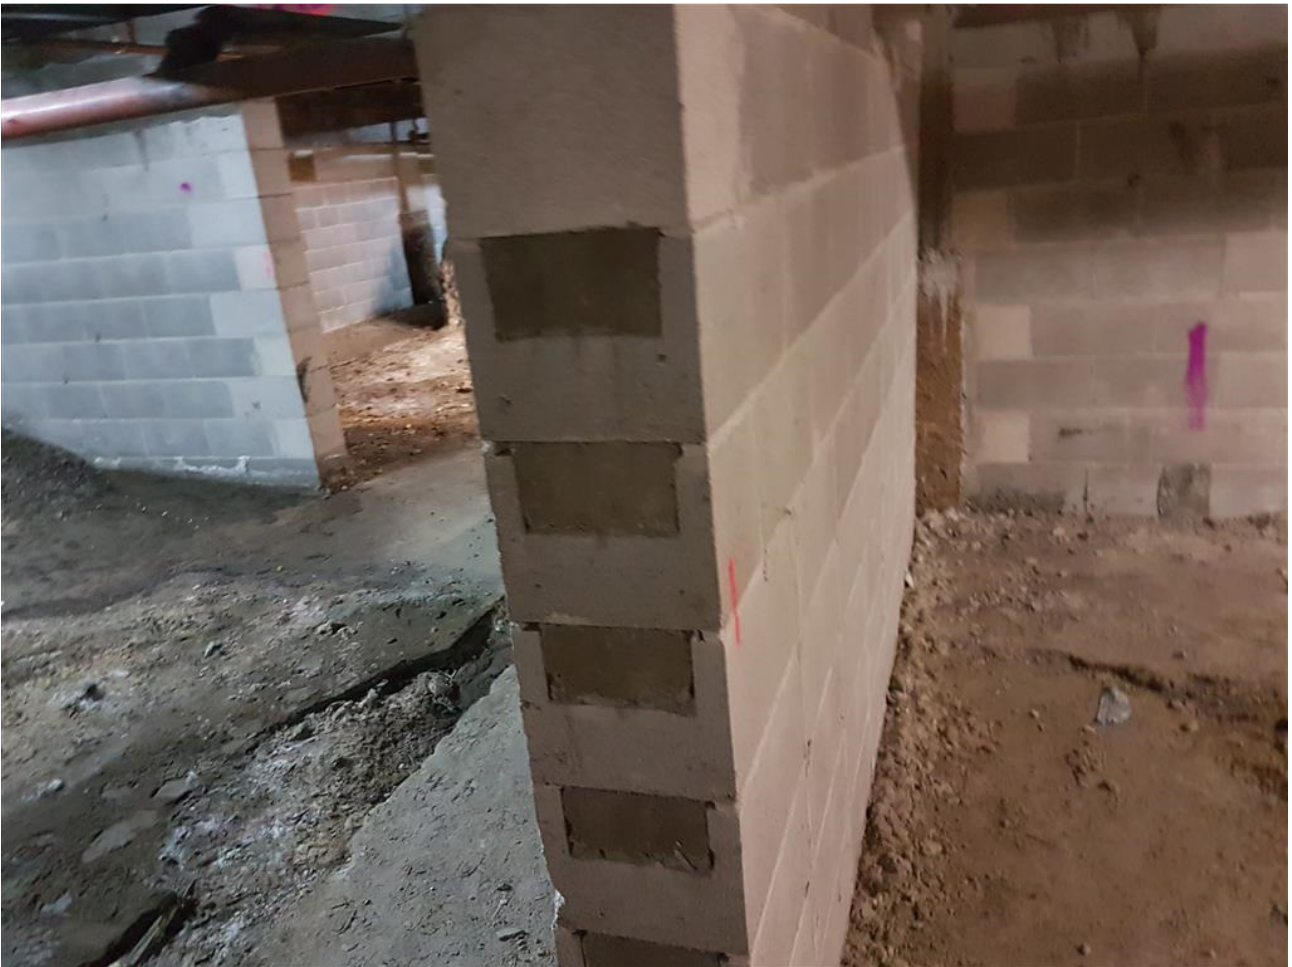
**Figure 56: Wall #24 – Rear left**

- Length= 1300mm+Opening+3200mm
- Height=2000 mm (2200 from drawings)
- Opening: Doorway
- Assumptions: Well dowelled.
- Structural Weaknesses: No strut action.

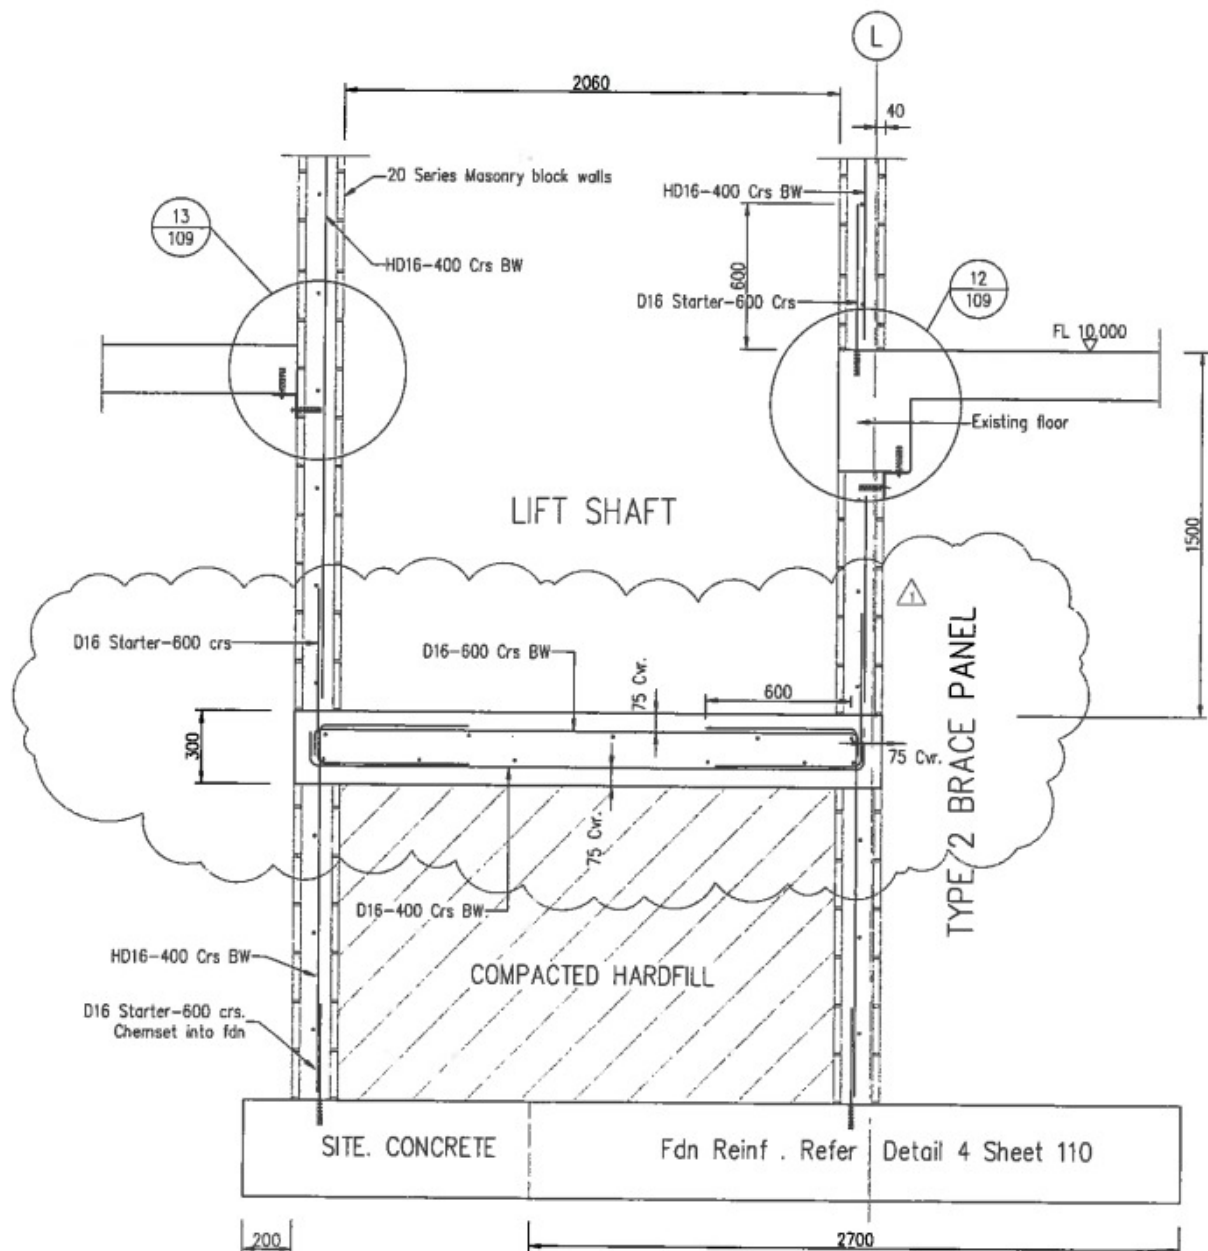
**Figure 62: Sketch of lift core**

- Length= Varies
- Height=2000 mm (1800 from drawings)
- Opening: None
- Assumptions: Well dowelled.
- Structural Weaknesses: Weakly jointed to concrete floor and beam at ground floor.

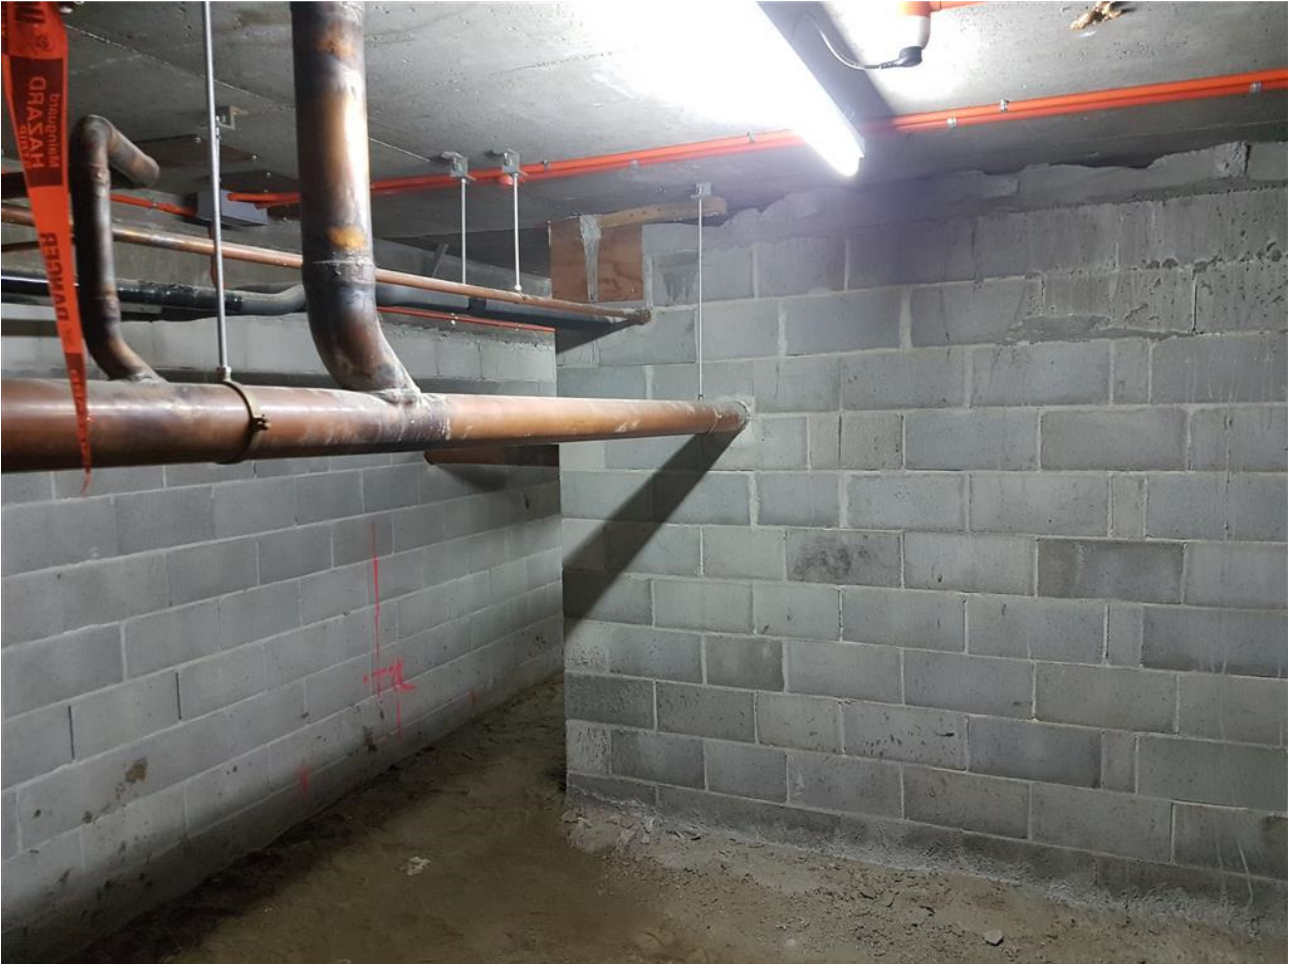
- Length= 2.5m
- Height=2200 mm (1800 from drawings)
- Opening: None
- Assumptions: None.
- Structural Weaknesses: Dowels un-grouted. No dowel action.
