Report on Acute Services Buildings

Hawke's Bay Fallen Soldiers Memorial Hospital
Hawke's Bay District Health Board

Understanding the Current Seismic Risk Status of the
Buildings

11 February 2022

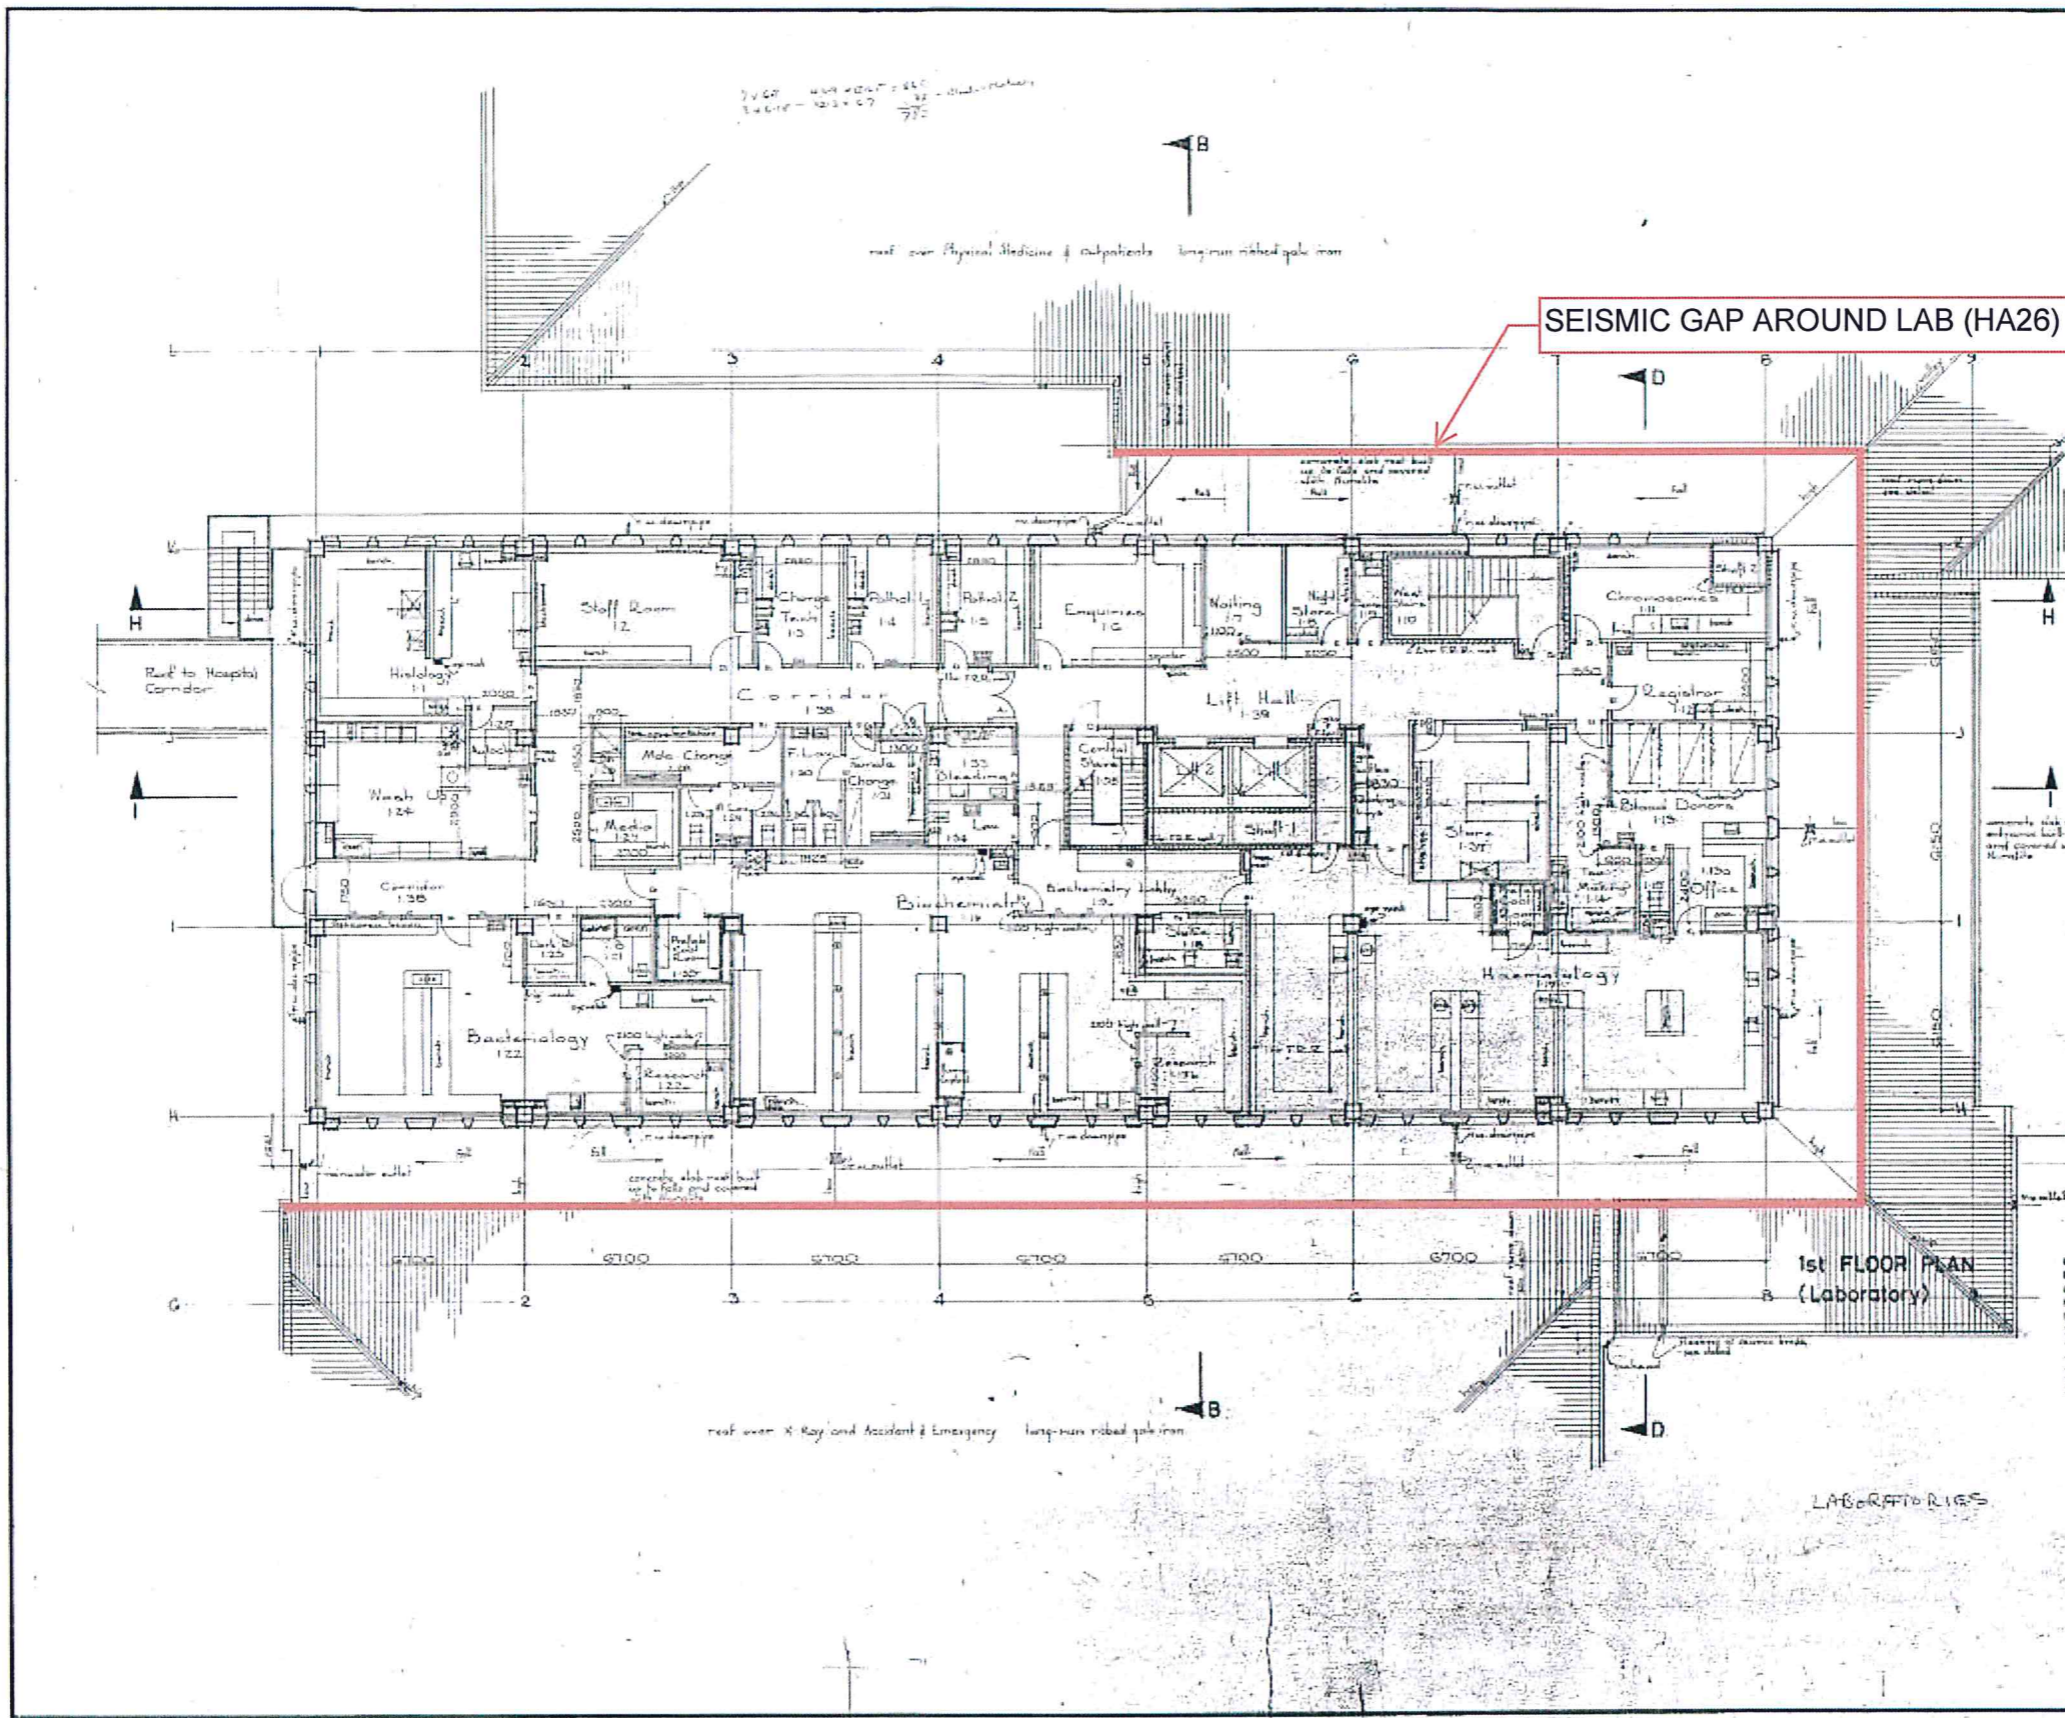
SEISMIC GAP AROUND LAB (HA26)

This shows that the original 1980's HA26 Laboratory Block is surrounded by a 50mm seismic gap at first floor level (eaves level for adjacent buildings) located one half grid width outside the building framing plan. This gap was continued for most of the 1990's extensions to adjacent buildings including the first-floor slab of HA34 AAU. Subsequent DSA's have found the 50mm gap to be insufficient for the expected displacements of HA26.

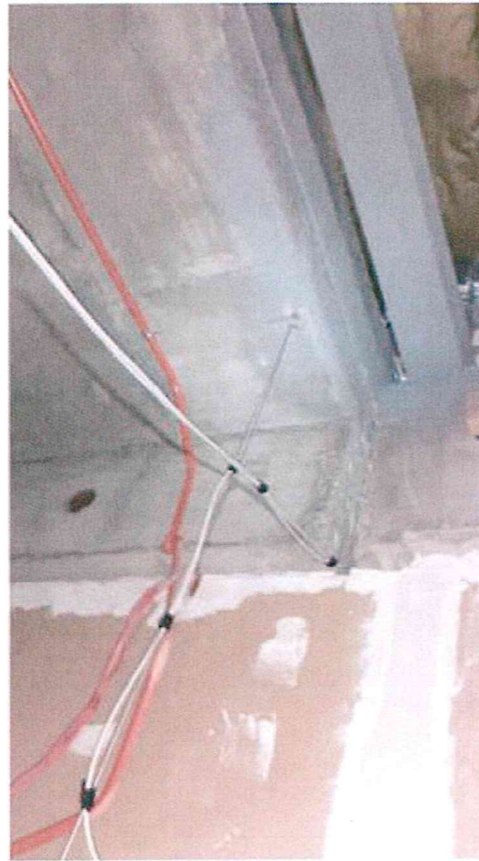
SEISMIC GAP BETWEEN LAB (HA27)
AND RADIOLOGY (HA26)

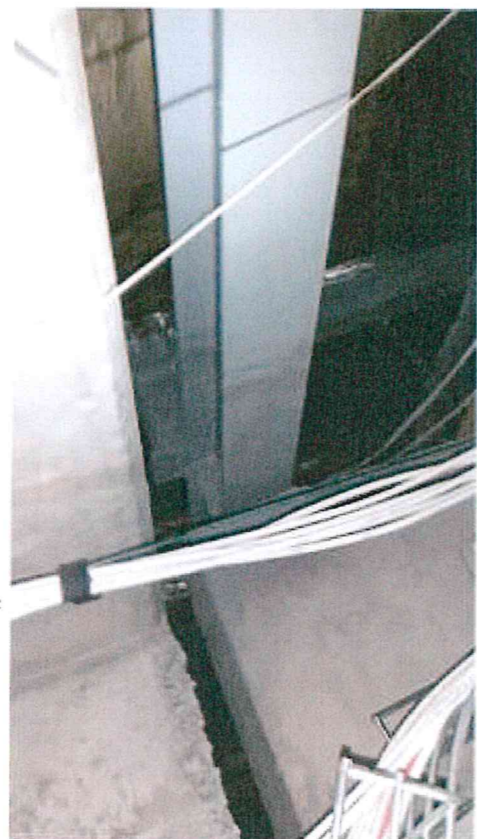
SEISMIC GAP BETWEEN LAB (HA26) AND ED (HA25)

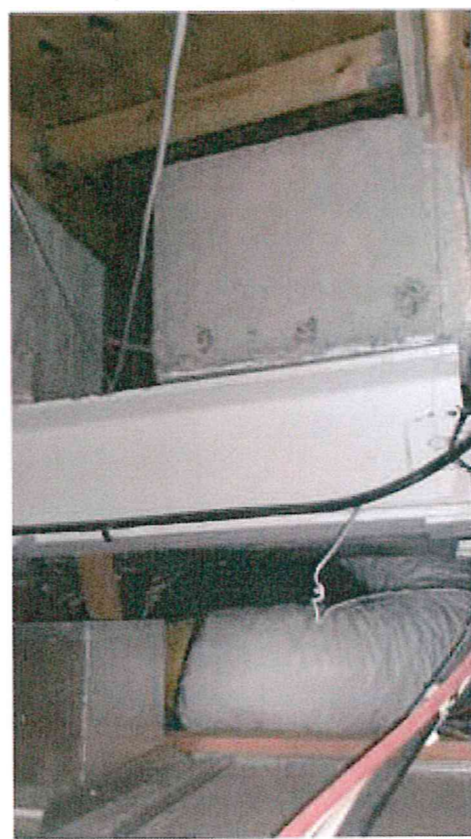
SEISMIC GAP BETWEEN LAB (HA26) AND AAU (HA34)

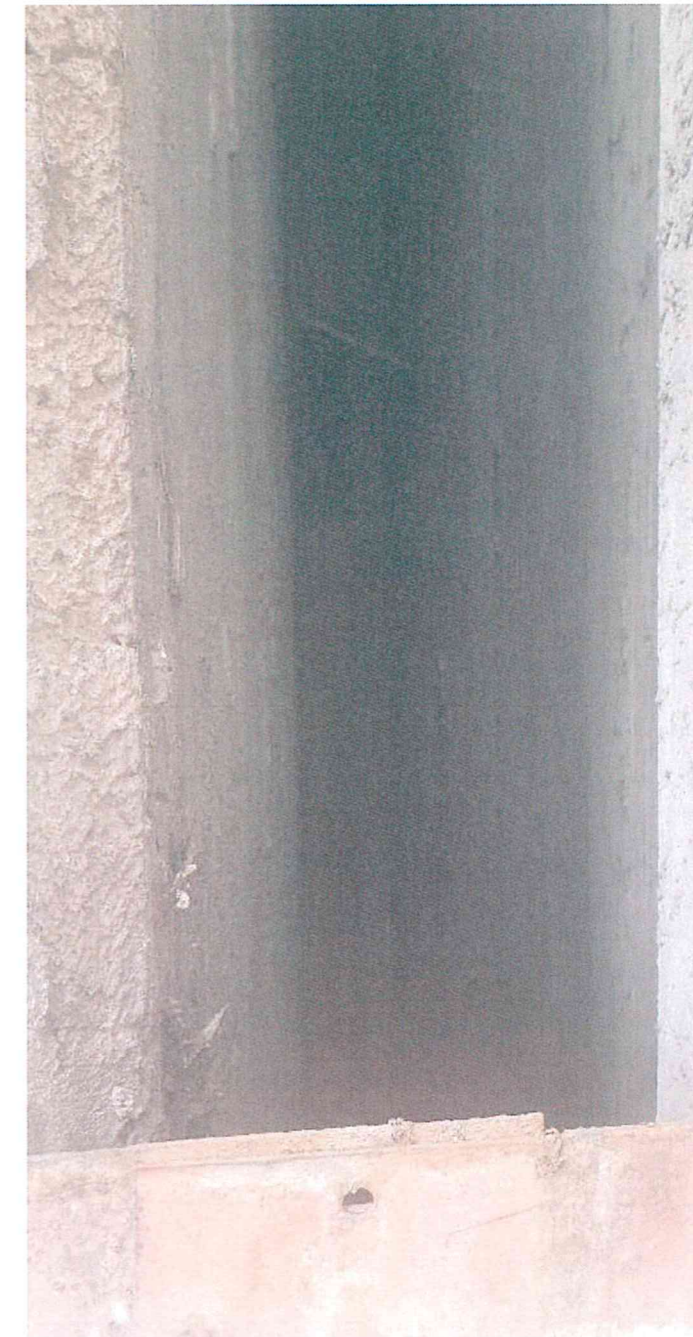
HA32 Block A and HA29 Block B are noted in their respective DSA's as having 150mm seismic gaps with HA31 Block AB and this was confirmed by photo. Holmes Group, as part of its time-history assessments of the blocks carried out a study on the interactions between the buildings. It found pounding between A/AB and AB/B is unlikely during a 1/500 year (IL2/ IL4, SLS2) seismic event and a 1/1000 year (IL3) seismic event but likely for both locations a 1/2500 year (IL4) seismic event. Strengthening would be required to reduce such relative movements

SEISMIC GAP BETWEEN A BLOCK (HA32) AND AB BLOCK (HA31)

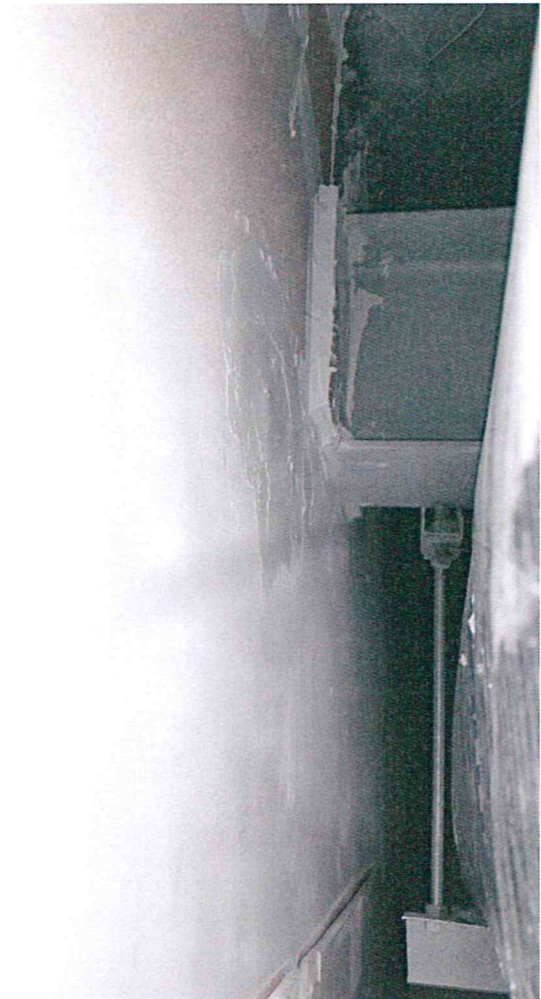
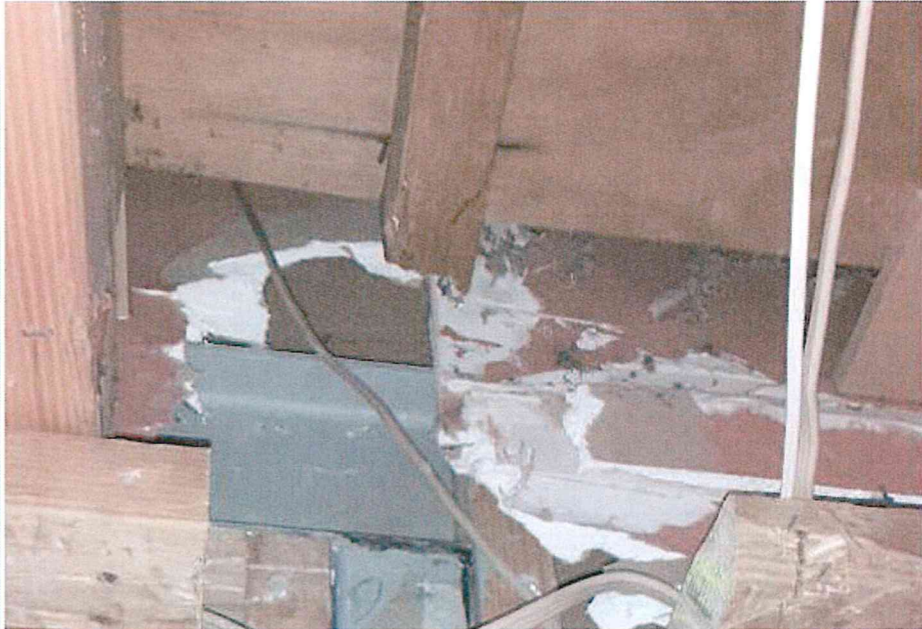
The main corridor which is part of HA37 Theatre Block was found to have no seismic gap with HA28 SCBU, HA27a Radiology Extension and HA26a Laboratory Extension with the corridor walls effectively built into the framing of the respective buildings. This would affect the response of the corridor, where it is likely the weakest link (possibly the link corridors on the other side of the main corridor) would tend to absorb any out of phase movements. The net result is likely to be deflections of the ceiling framing leading to collapse of areas of light weight ceiling tiles.

TYPICAL THEATRE CORRIDOR SECTION (GRID LINE H AGAINST ADJACENT BUILDING WITHOUT GAP)

STEEL RAFTER ABOVE CORRIDOR CONNECTS TO STEEL BEAM BETWEEN POSTS ON ADJACENT BUILDING (PHOTO TAKEN FROM CORRIDOR)
