# **AAU Histology Block Hawke's Bay Hospital**

**Detailed Seismic Assessment**

# **AAU, Pharmacy, Dialysis Block HA34**

### **Detailed Seismic Assessment**

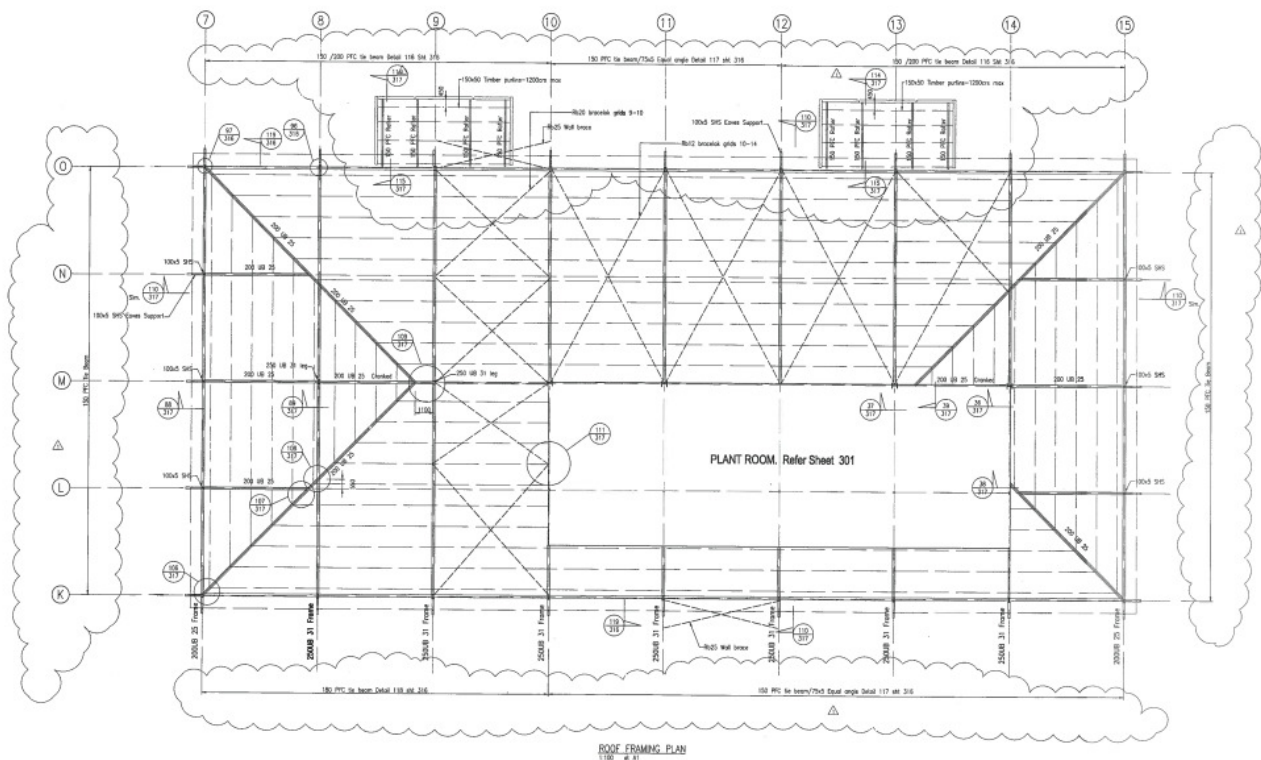
**Figure 29: Roof Framing Plan**

Results from the assessment show that in the longitudinal direction, the rating is limited by either the roof diaphragm (compression of purlins) or by the connections of the longitudinal bracing to the side frames. The analysis shows that the vertical braces are limited by their connection to the main portal frames that are eccentric and by their connection to the base plates. In the latter case, shear capacity is limited by concrete break-out, which is a non-ductile failure. Also, the cleat weld has a big limitation on the load that can be withstood. The rating obtained is less 15%NBS for this item for both IL3 and IL4 importance levels.

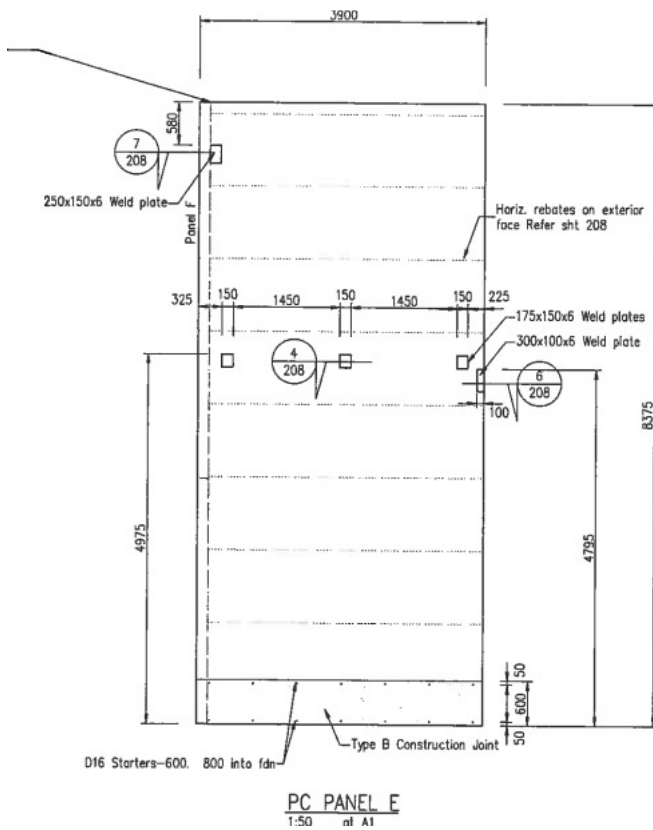
Figure 32: Typical wall detail (notice foundation thickness and reinforcement)

As can be seen, the panels are connected to each other through weld plates and are connected to the foundation on their side with D16 starters at 600crs. The gravity structure of the stair is comprised of steel members, welded to cast-in weld plates, with precast floor slabs for the landings and flights. All these elements are resting on top of the walls, which in turn take the load to the foundation. The lateral structural system is achieved through the in-plane action of the walls. At the roof level, the roof is connected to a collector on the roof bulkhead. The side panels also have a welded connection to an angle bolted into the existing first-floor beams.

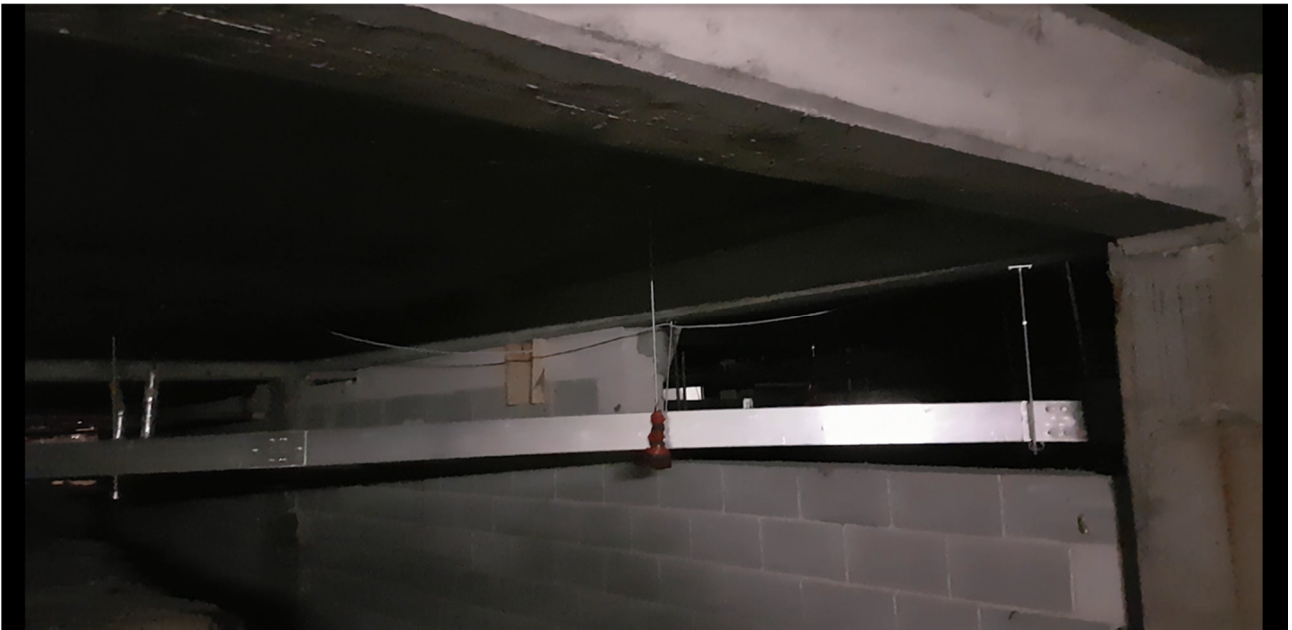
**Figure 40: Wall No. 5 (left) and 6 (right)**

Wall No. 5 has the following geometry and structural weaknesses:

- Length= 6100mm
- Height=2000mm (1600 mm from as-built drawings)
- No Openings
- Assumptions: Fully grouted against frame. Properly dowelled.
- Structural Weaknesses: None.

- Length= 6100mm
- Height=2000mm (1600 mm from as-built drawings)
- Opening to one side: 2200mmx500
- Assumptions:
- Structural Weaknesses: Opening, Eccentric strut action, deficient dowelling and grouting at opposite top corner from opening. Short column effect leads to shear failure of column.

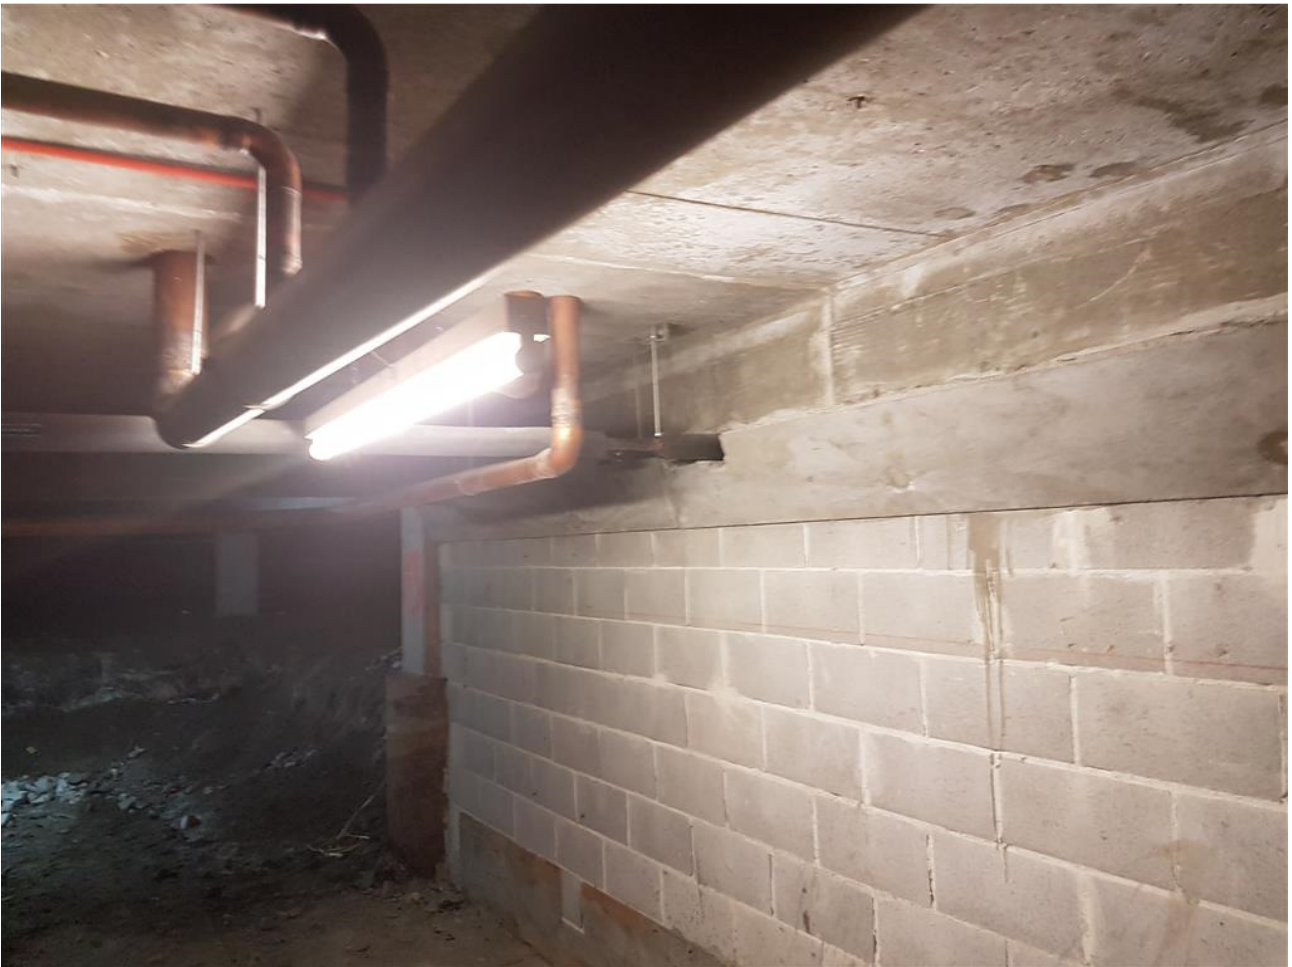
**Figure 42: Wall #8**

Wall No. 8 has the following geometry and structural weaknesses:

- Length= 6100
- Height=2000mm (2000 mm from as-built drawings)
- Opening: no openings
- Assumptions: Strut can be formed.
- Structural Weaknesses: Doweling ok.

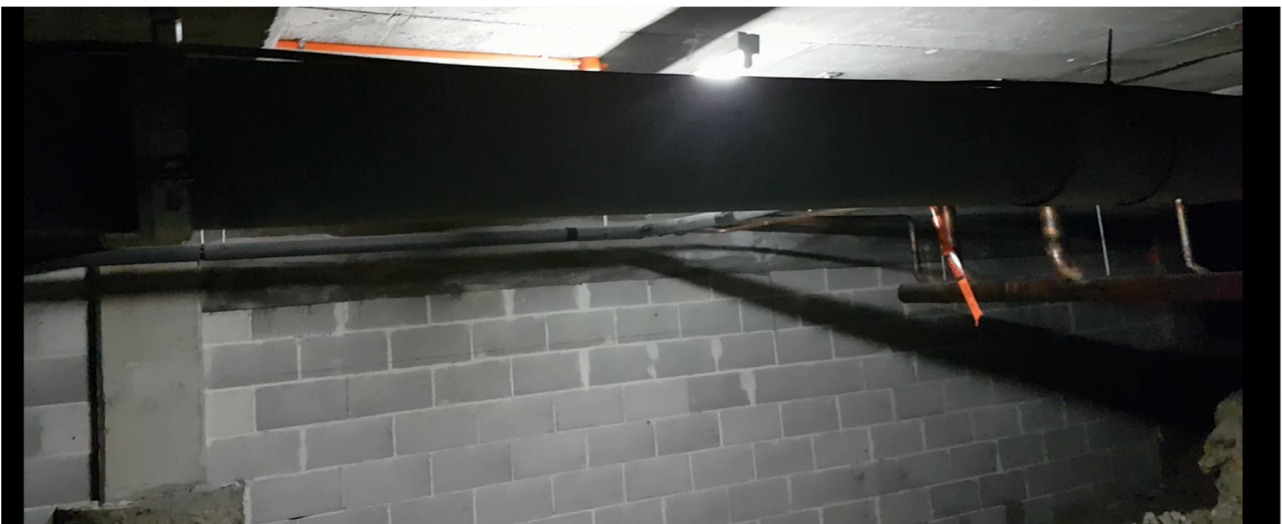
Figure 47: Wall 14

Wall No. 14 has the following geometry and structural weaknesses:

- Length= 6100mm
- Height=2000mm (1900 mm from as-built drawings)
- Opening: No Openings
- Assumptions: None.
- Structural Weaknesses: None.

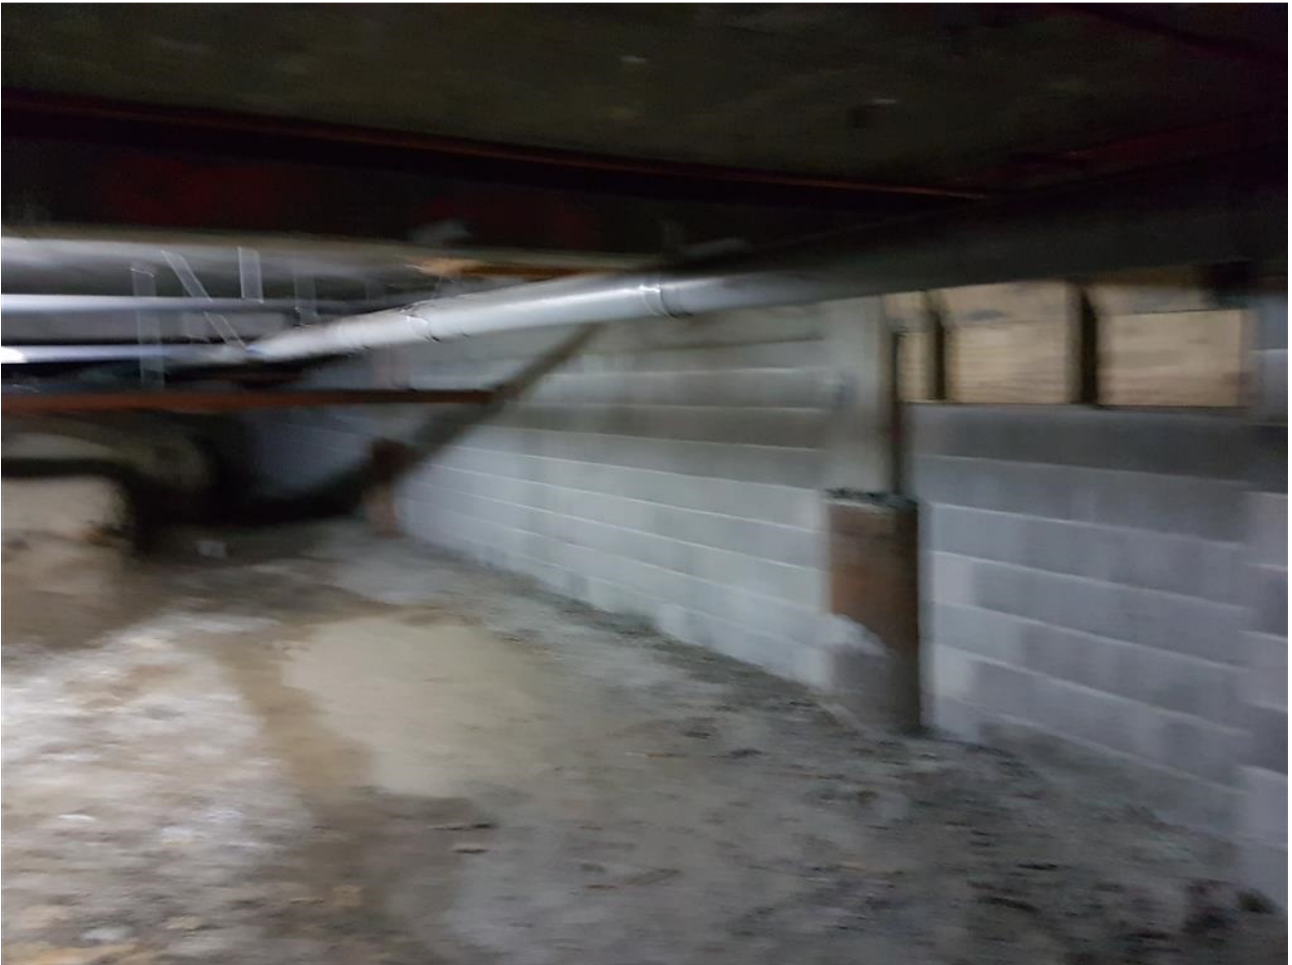
**Figure 49: Walls 15, 16 and 17**

Wall No. 16 has the following geometry and structural weaknesses:

- Length= 6100mm
- Height=2000mm (1800 mm from as-built drawings)
- Opening: No Openings.
- Assumptions: Wall dowelled correctly.
- Structural Weaknesses: None.

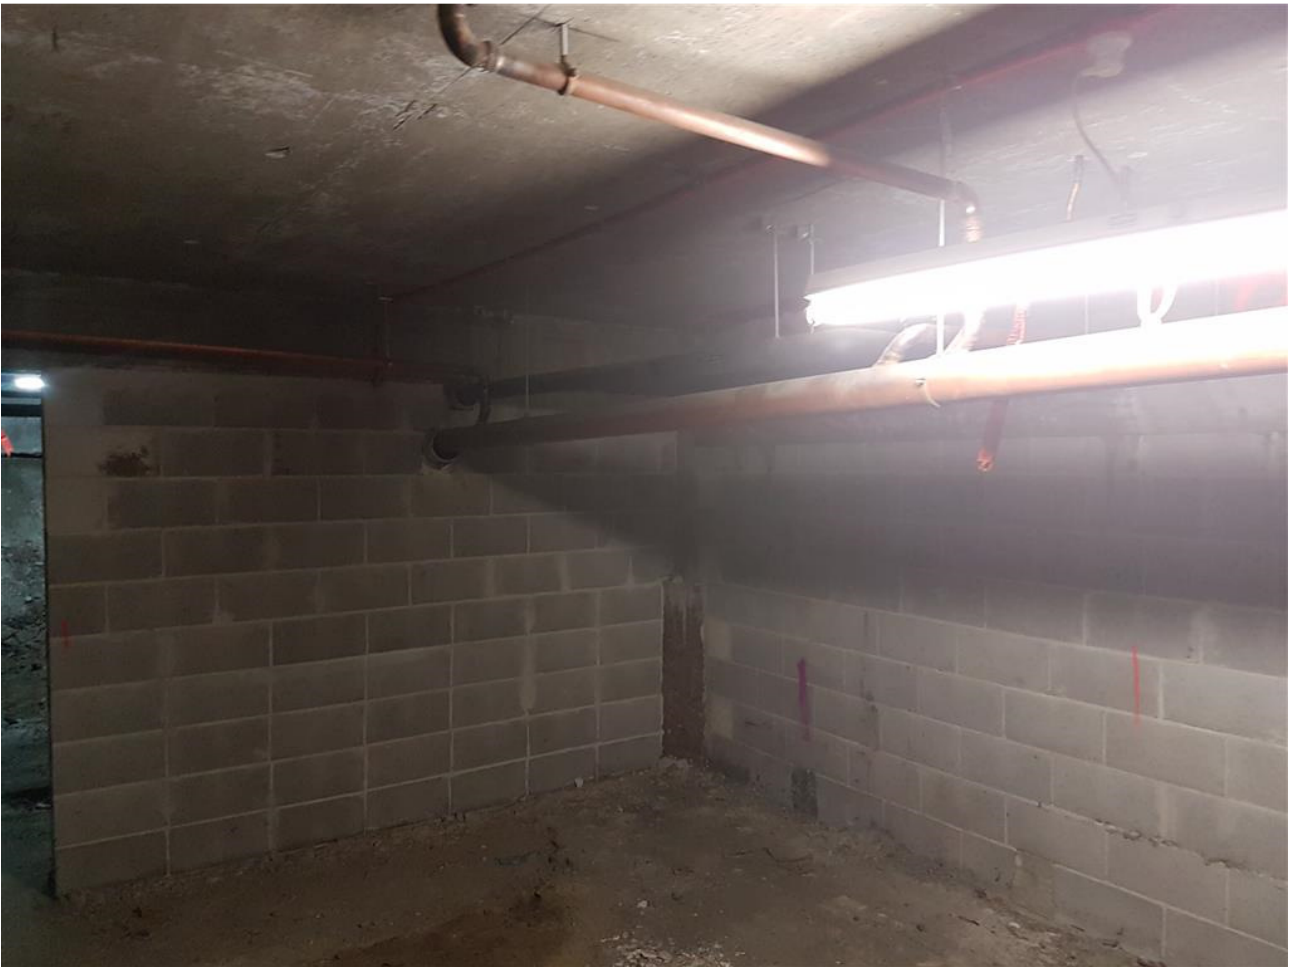
**Figure 58: Wall #26 – Wall 26 (right)**

Wall No. 26 has the following geometry and structural weaknesses:

- Length= 5500mm
- Height=2000 mm (2200 from drawings)
- Opening: No Opening
- Assumptions: Well dowelled.
- Structural Weaknesses: None

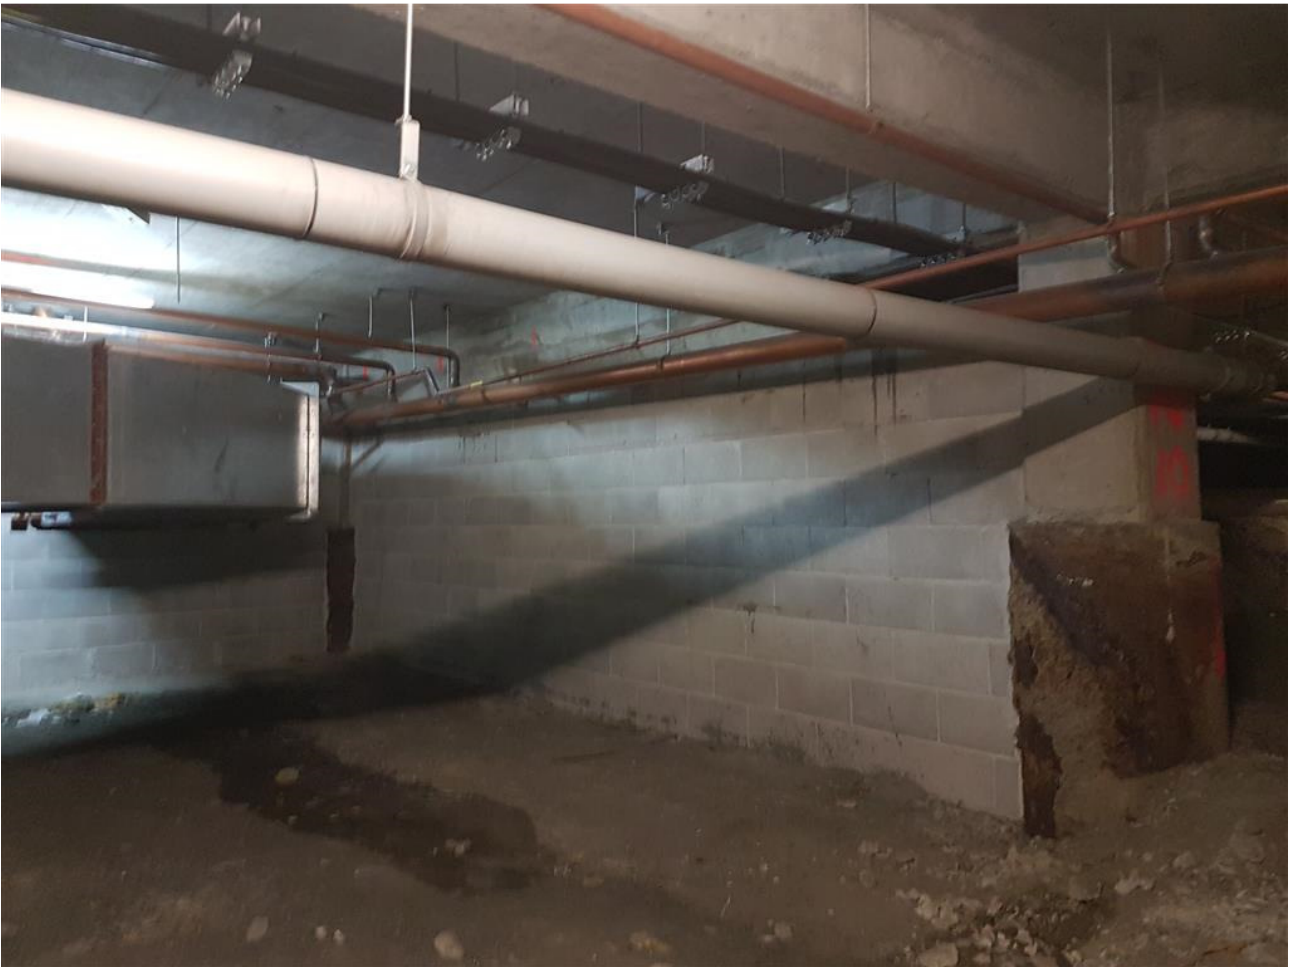
**Figure 59: Wall #28**

Wall No. 28 has the following geometry and structural weaknesses:

- Length= 5500mm
- Height=2000 mm (400 from drawings)
- Opening: Small duct opening at top corner. (150mmx600mm)
- Assumptions:
- Structural Weaknesses: None.

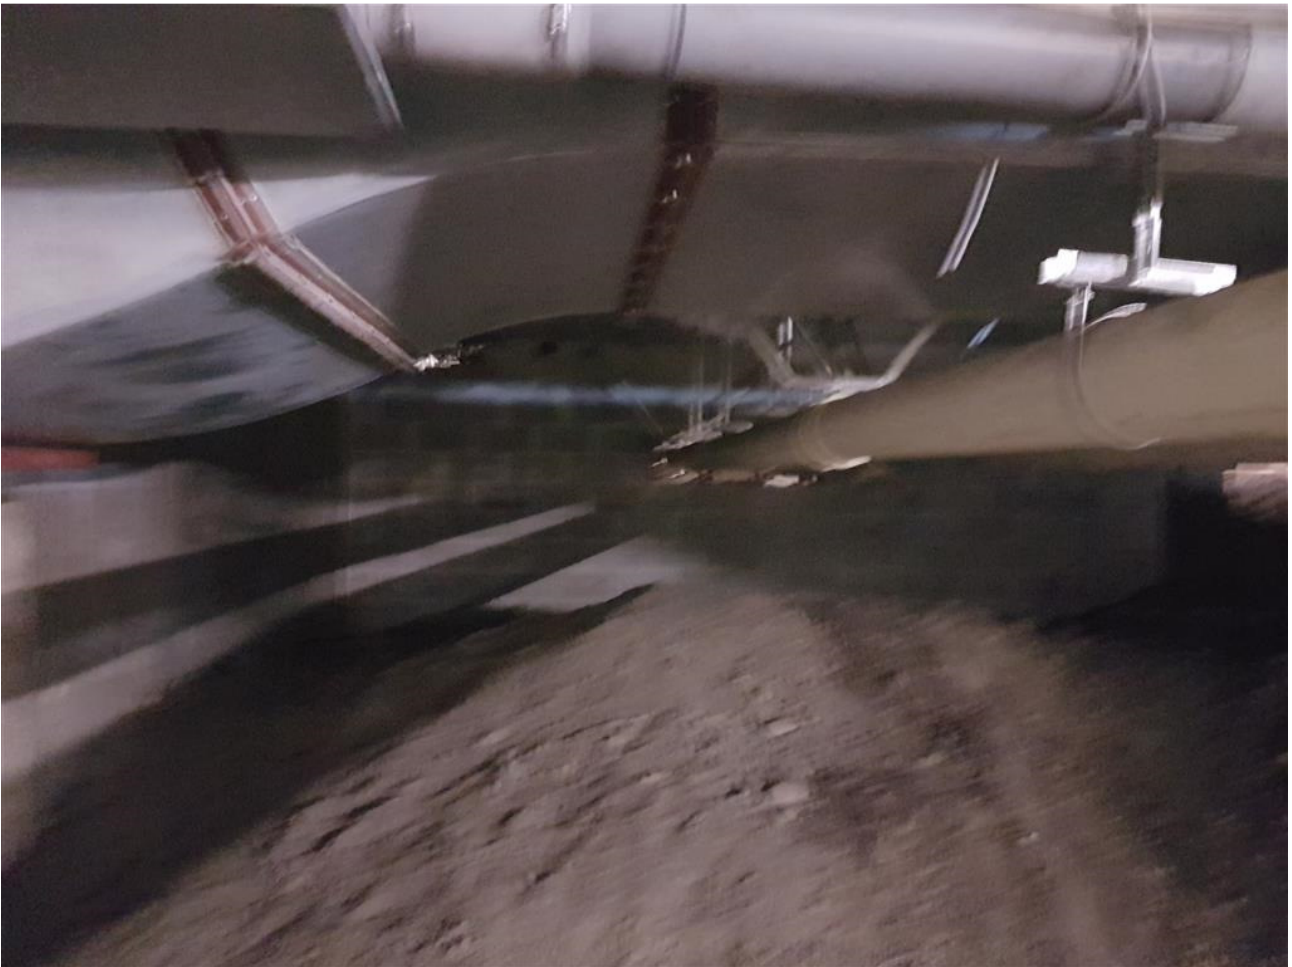
**Figure 60: Wall #30**

Wall No. 30 has the following geometry and structural weaknesses:

- Length= 5500mm
- Height=2000 mm (1800 from drawings)
- Opening: Small pipe through
- Assumptions: Well dowelled.
- Structural Weaknesses: None.

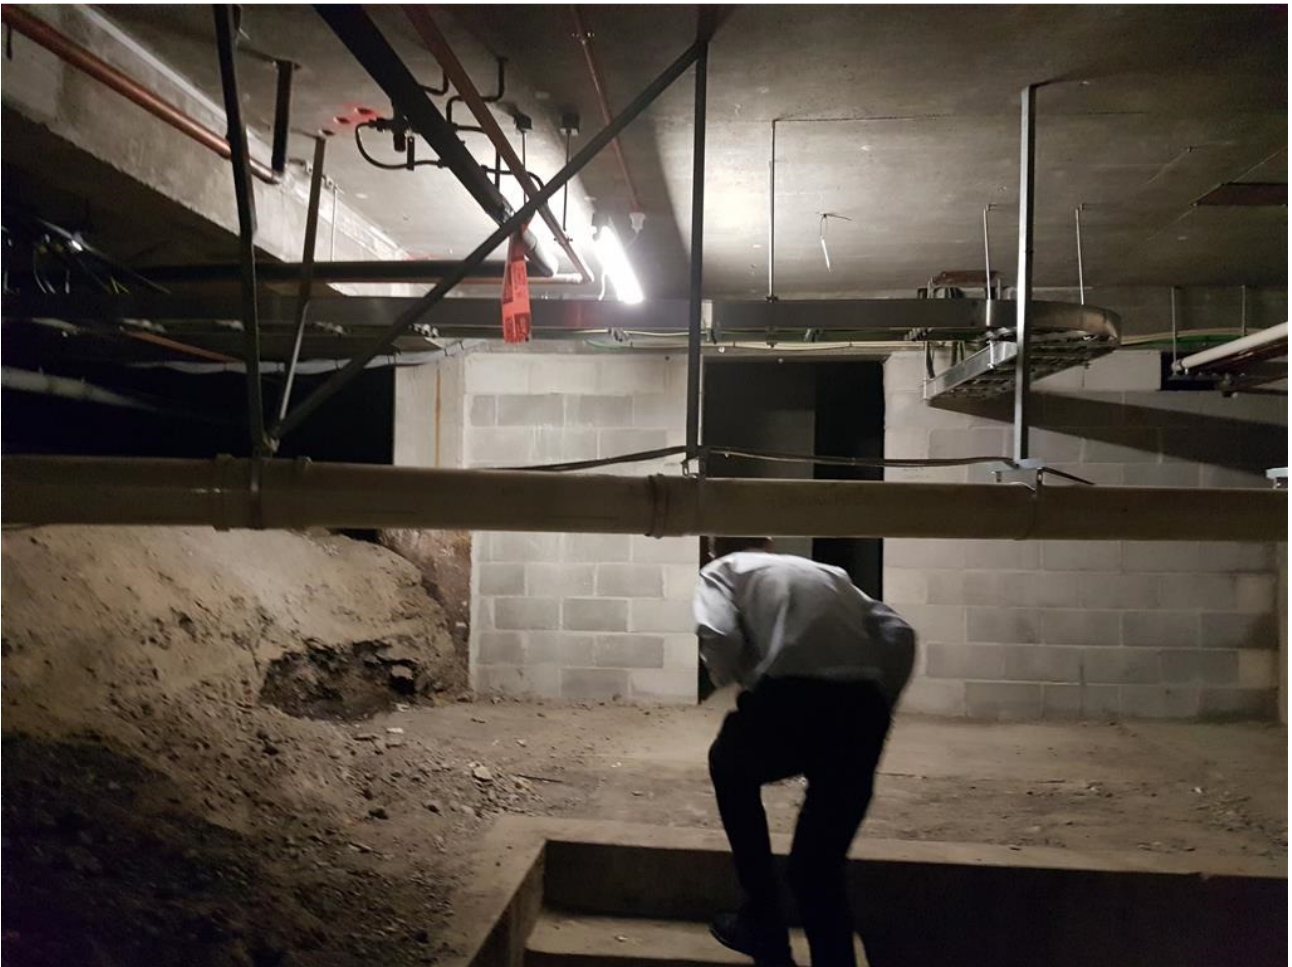
**Figure 61: Wall #31**

Wall No. 31 has the following geometry and structural weaknesses:

- Length= 1300mm+opening+2000mm
- Height=2000 mm (1800 from drawings)
- Opening: Doorway +duct opening left top corner
- Assumptions: Well dowelled.
- Structural Weaknesses: None.
